# Land Information Memorandum

Property address:  
250 Styx Mill Road

LIM number: H00892132  
Page 1

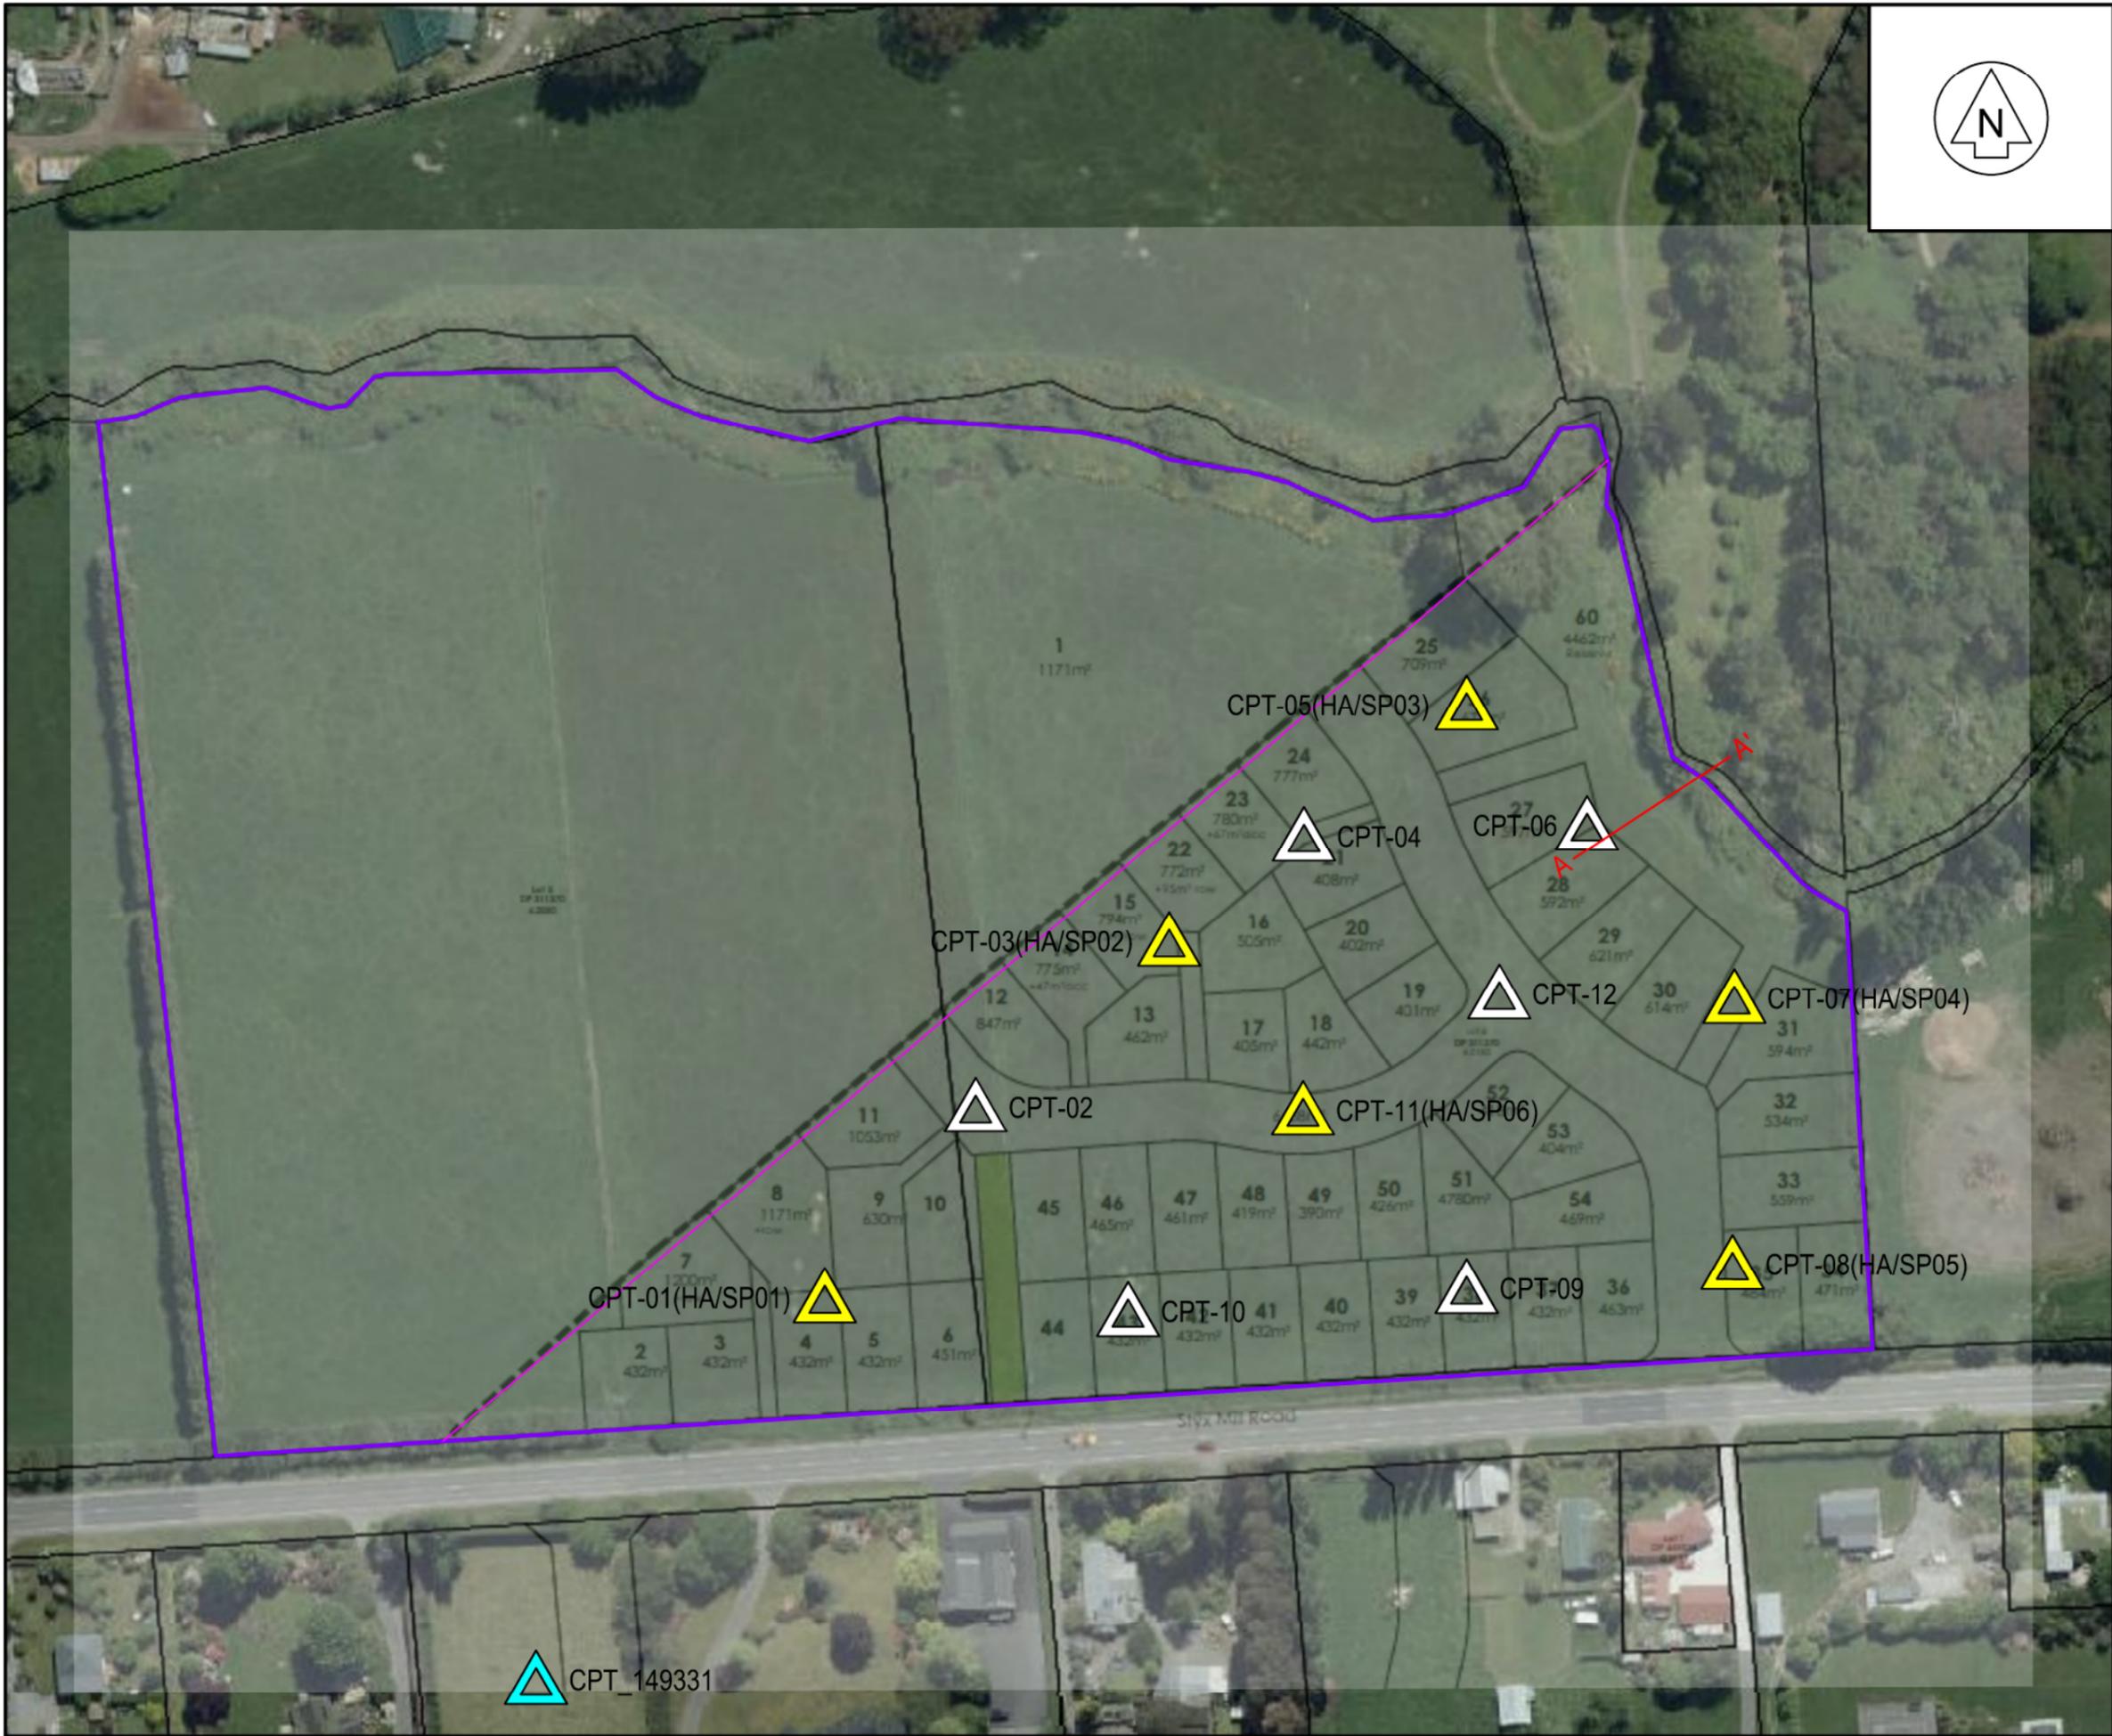
The exploratory borehole locations were selected to provide representative indications of the subsurface ground conditions within the area being assessed. The exploratory test locations are indicated on our Site Plan, attached as Sheet 1.

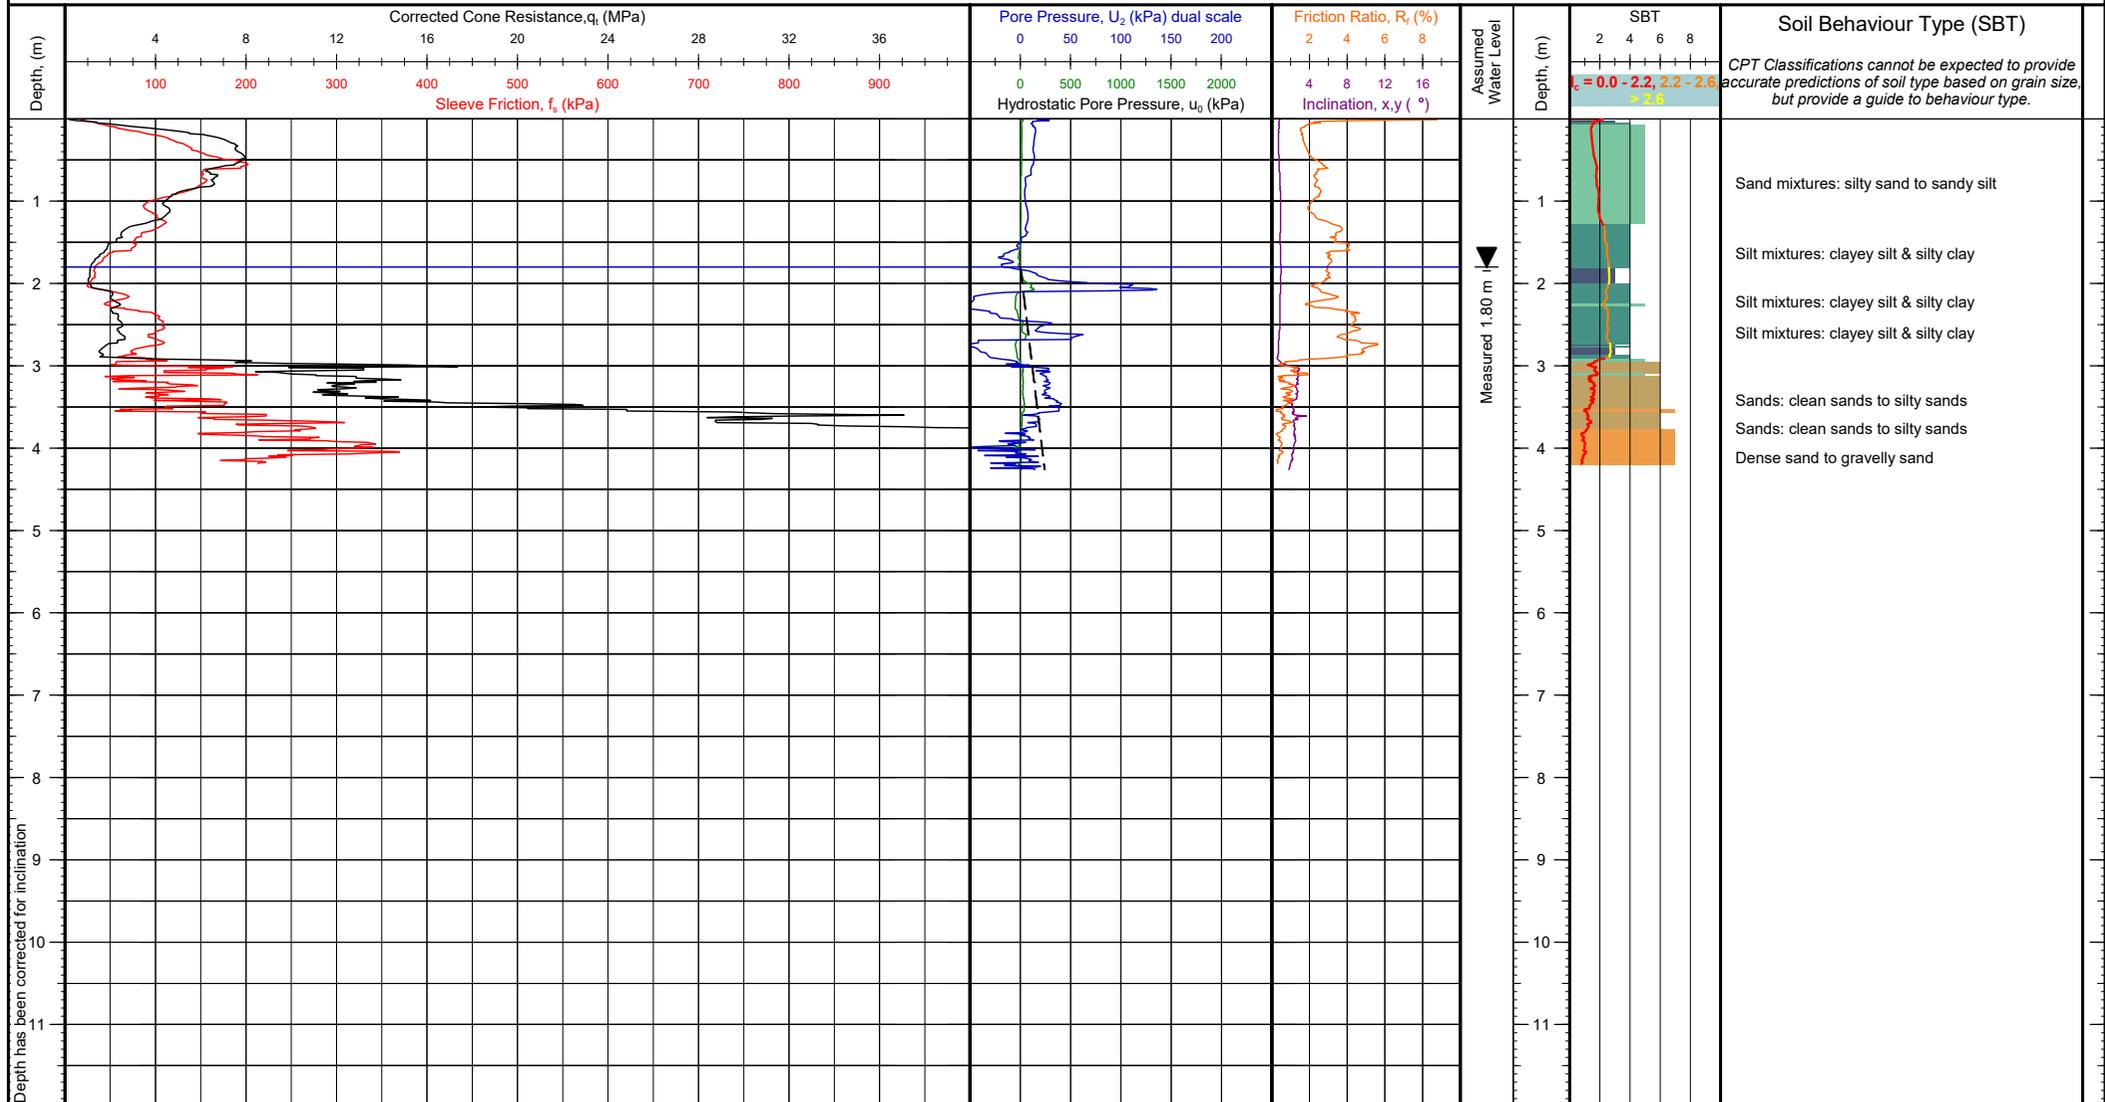
# CONE PENETRATION TEST (CPT) LOG

<b>Client:</b> KGA Geotechnical	<b>Operator:</b> John Cresswell	<b>NZTM 2000 N, E (m):</b> 5187240.03, 1567296.04	<b>Elevation (m):</b> Unknown	<b>Client Reference:</b>
<b>Project:</b> 232 Styx Mill Road	<b>Cone Ref:</b> MKJ539	<b>WGS84 (deg):</b> -43.467037, 172.595690	<b>Date of Test:</b> 18/05/2021	<b>Test Number:</b> <b>CPT-01</b>
<b>Location:</b> Casebrook, Christchurch	<b>Cone Type:</b> 10cm <sup>2</sup> Compression	<b>Location Method:</b> Handheld GPS	<b>Depth (m):</b> 4.26	
<b>Engineer:</b> Abilio Nogueira	<b>Area Ratio:</b> 0.79	<b>Surveyor:</b>	<b>Pre Drill (m):</b> N/A	<b>G.I. Job Ref:</b> 210503
<b>Contractor:</b> Ground Investigation Ltd	<b>Filter Type:</b> $u_2$	<b>Termination Reason:</b> High cone end resistance

The NZGD website was searched for geotechnical information in the form of relevant well/borehole logs and CPT data. One Cone Penetrometer Test (CPT) was found in the vicinity of the property. The log is reproduced in Appendix C, and is referenced further in Section 7.1 of this report.

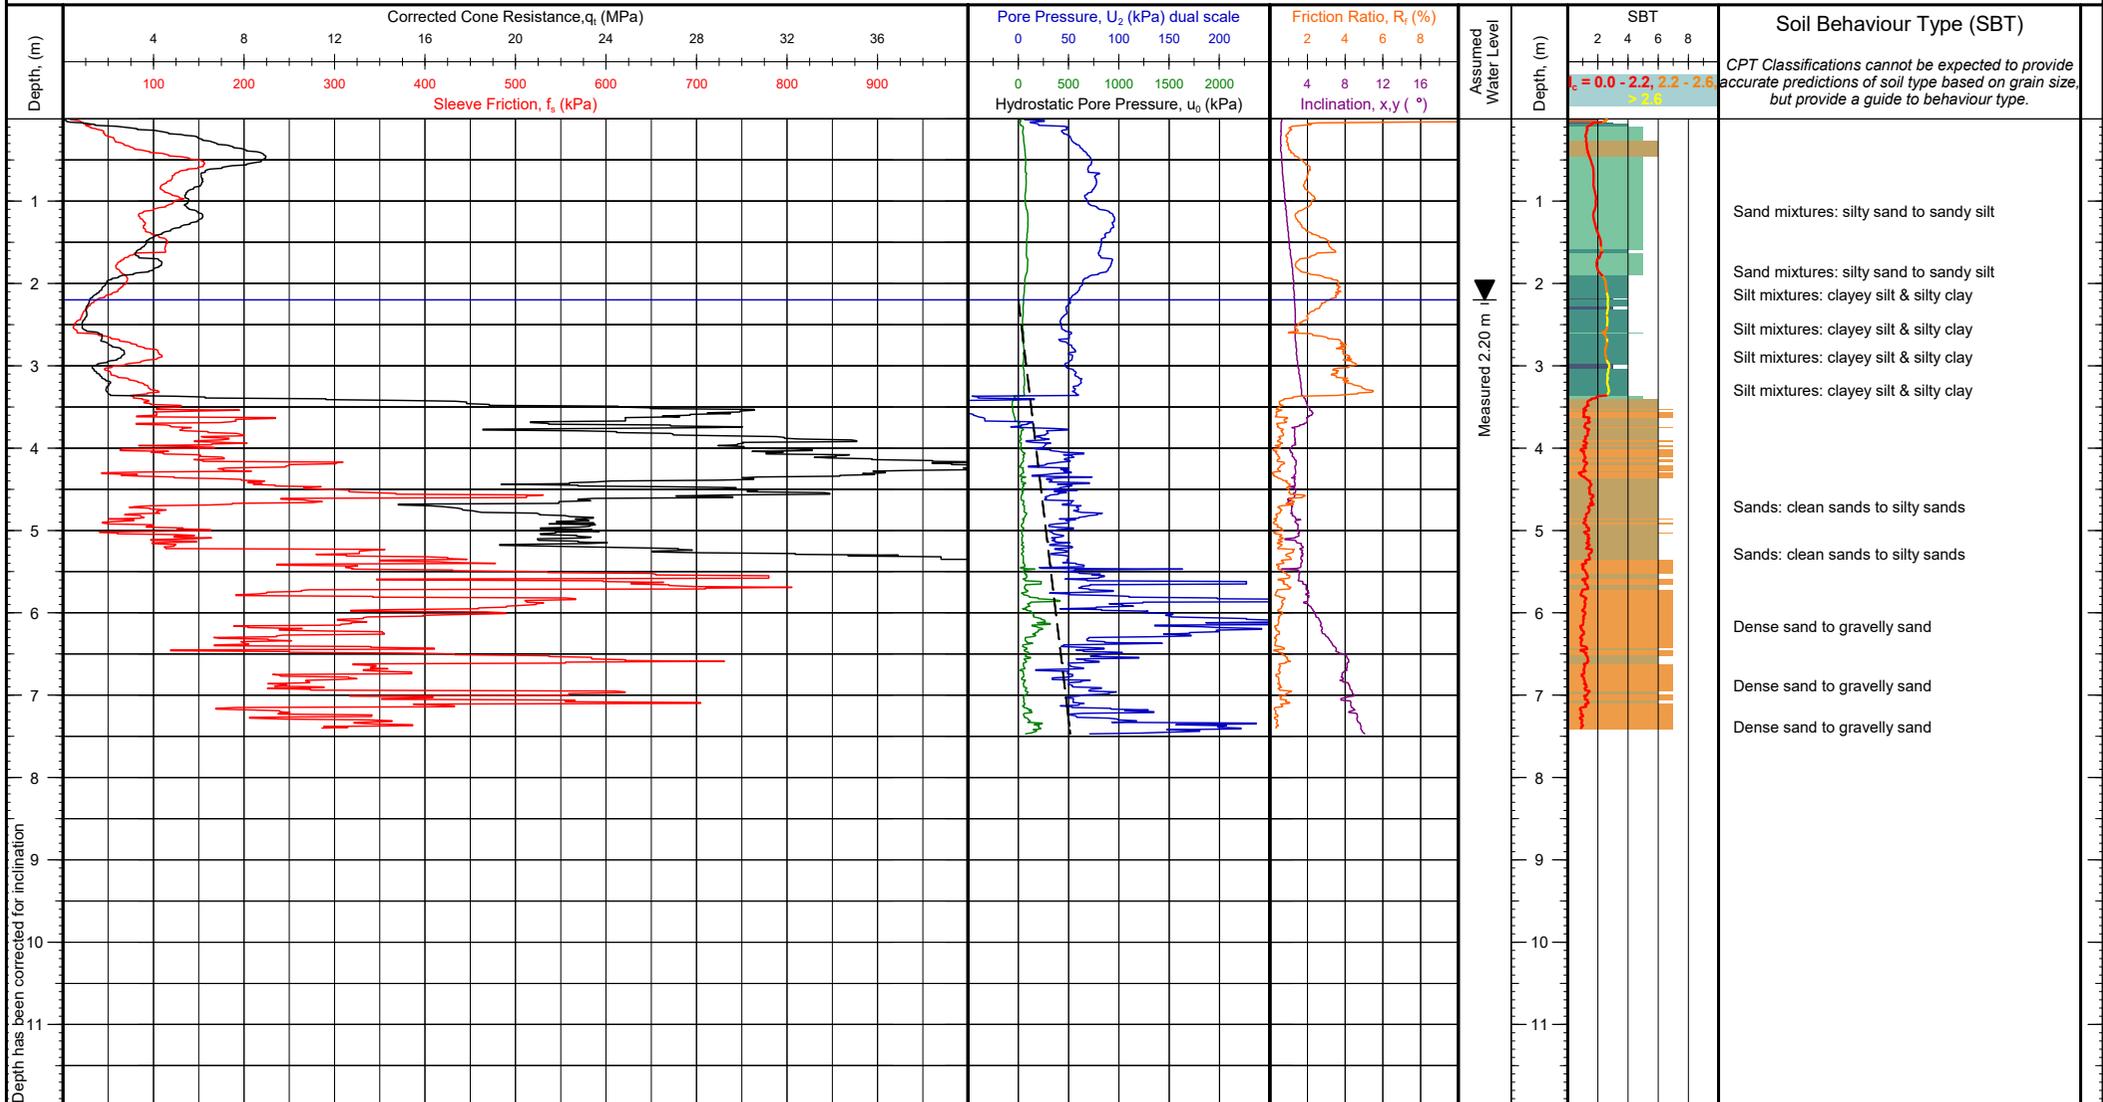
# CONE PENETRATION TEST (CPT) LOG

<b>Client:</b> KGA Geotechnical	<b>Operator:</b> John Cresswell	<b>NZTM 2000 N, E (m):</b> 5187276.53, 1567333.31	<b>Elevation (m):</b> Unknown	<b>Client Reference:</b>
<b>Project:</b> 232 Styx Mill Road	<b>Cone Ref:</b> MKJ335	<b>WGS84 (deg):</b> -43.466710, 172.596153	<b>Date of Test:</b> 18/05/2021	
<b>Location:</b> Casebrook, Christchurch	<b>Cone Type:</b> 10cm <sup>2</sup> Compression	<b>Location Method:</b> Handheld GPS	<b>Depth (m):</b> 7.47	<b>Test Number:</b> <b>CPT-02</b>
<b>Engineer:</b> Abilio Nogueira	<b>Area Ratio:</b> 0.78	<b>Surveyor:</b>	<b>Pre Drill (m):</b> N/A	
<b>Contractor:</b> Ground Investigation Ltd	<b>Filter Type:</b> $u_2$	<b>Termination Reason:</b> High cone end resistance		<b>G.I. Job Ref:</b> 210503

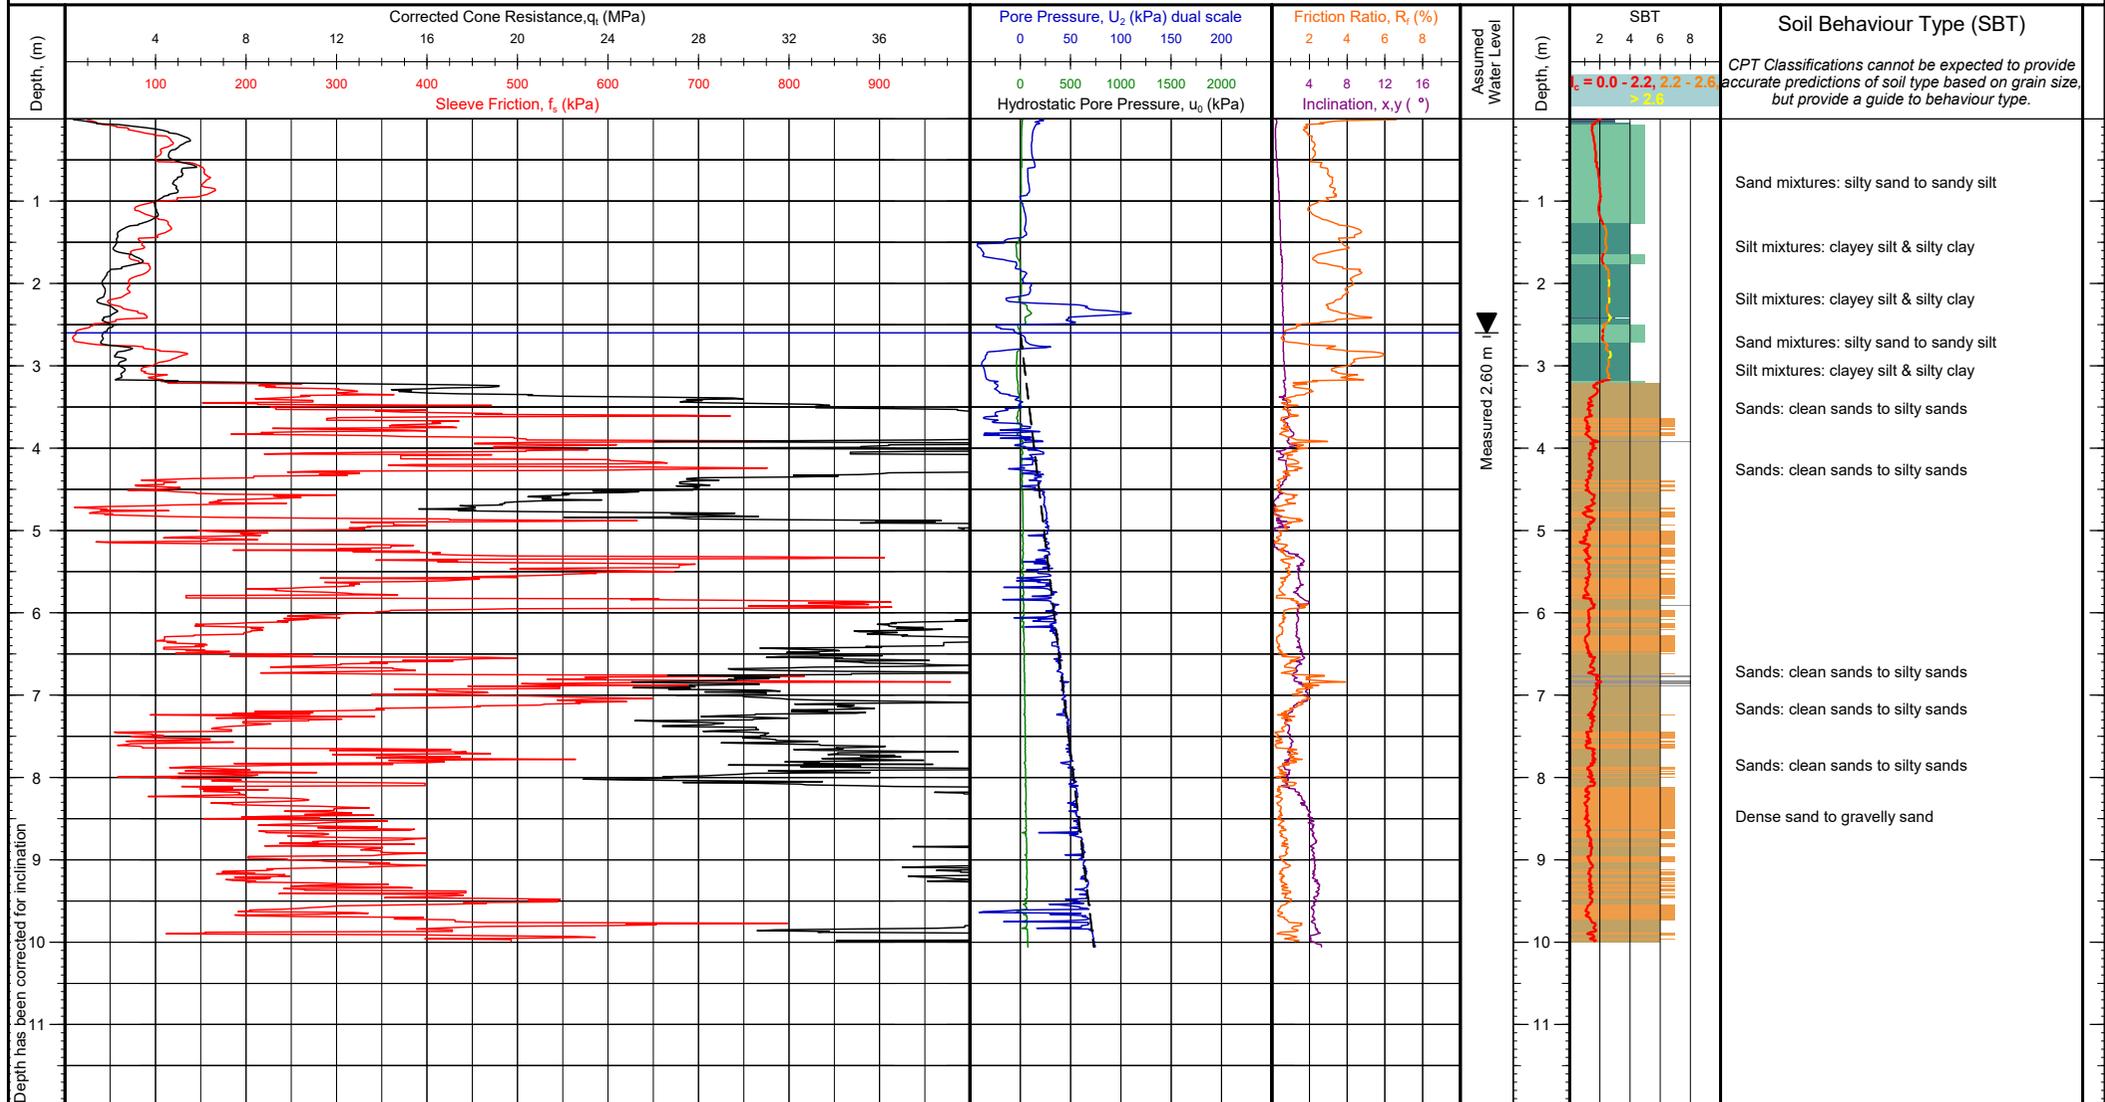
# CONE PENETRATION TEST (CPT) LOG

<b>Client:</b> KGA Geotechnical <b>Project:</b> 232 Styx Mill Road <b>Location:</b> Casebrook, Christchurch <b>Engineer:</b> Abilio Nogueira <b>Contractor:</b> Ground Investigation Ltd	<b>Operator:</b> John Cresswell <b>Cone Ref:</b> MKJ539 <b>Cone Type:</b> 10cm <sup>2</sup> Compression <b>Area Ratio:</b> 0.79 <b>Filter Type:</b> u <sub>2</sub>	<b>NZTM 2000 N, E (m):</b> 5187320.90, 1567368.69	<b>Elevation (m):</b> Unknown	<b>Client Reference:</b>
		<b>WGS84 (deg):</b> -43.466312, 172.596593	<b>Date of Test:</b> 18/05/2021	
<b>Comments:</b>		<b>Location Method:</b> Handheld GPS	<b>Depth (m):</b> 10.06	<b>Test Number:</b> <b>CPT-03</b>
		<b>Surveyor:</b>	<b>Pre Drill (m):</b> N/A	
		<b>Termination Reason:</b> Target depth

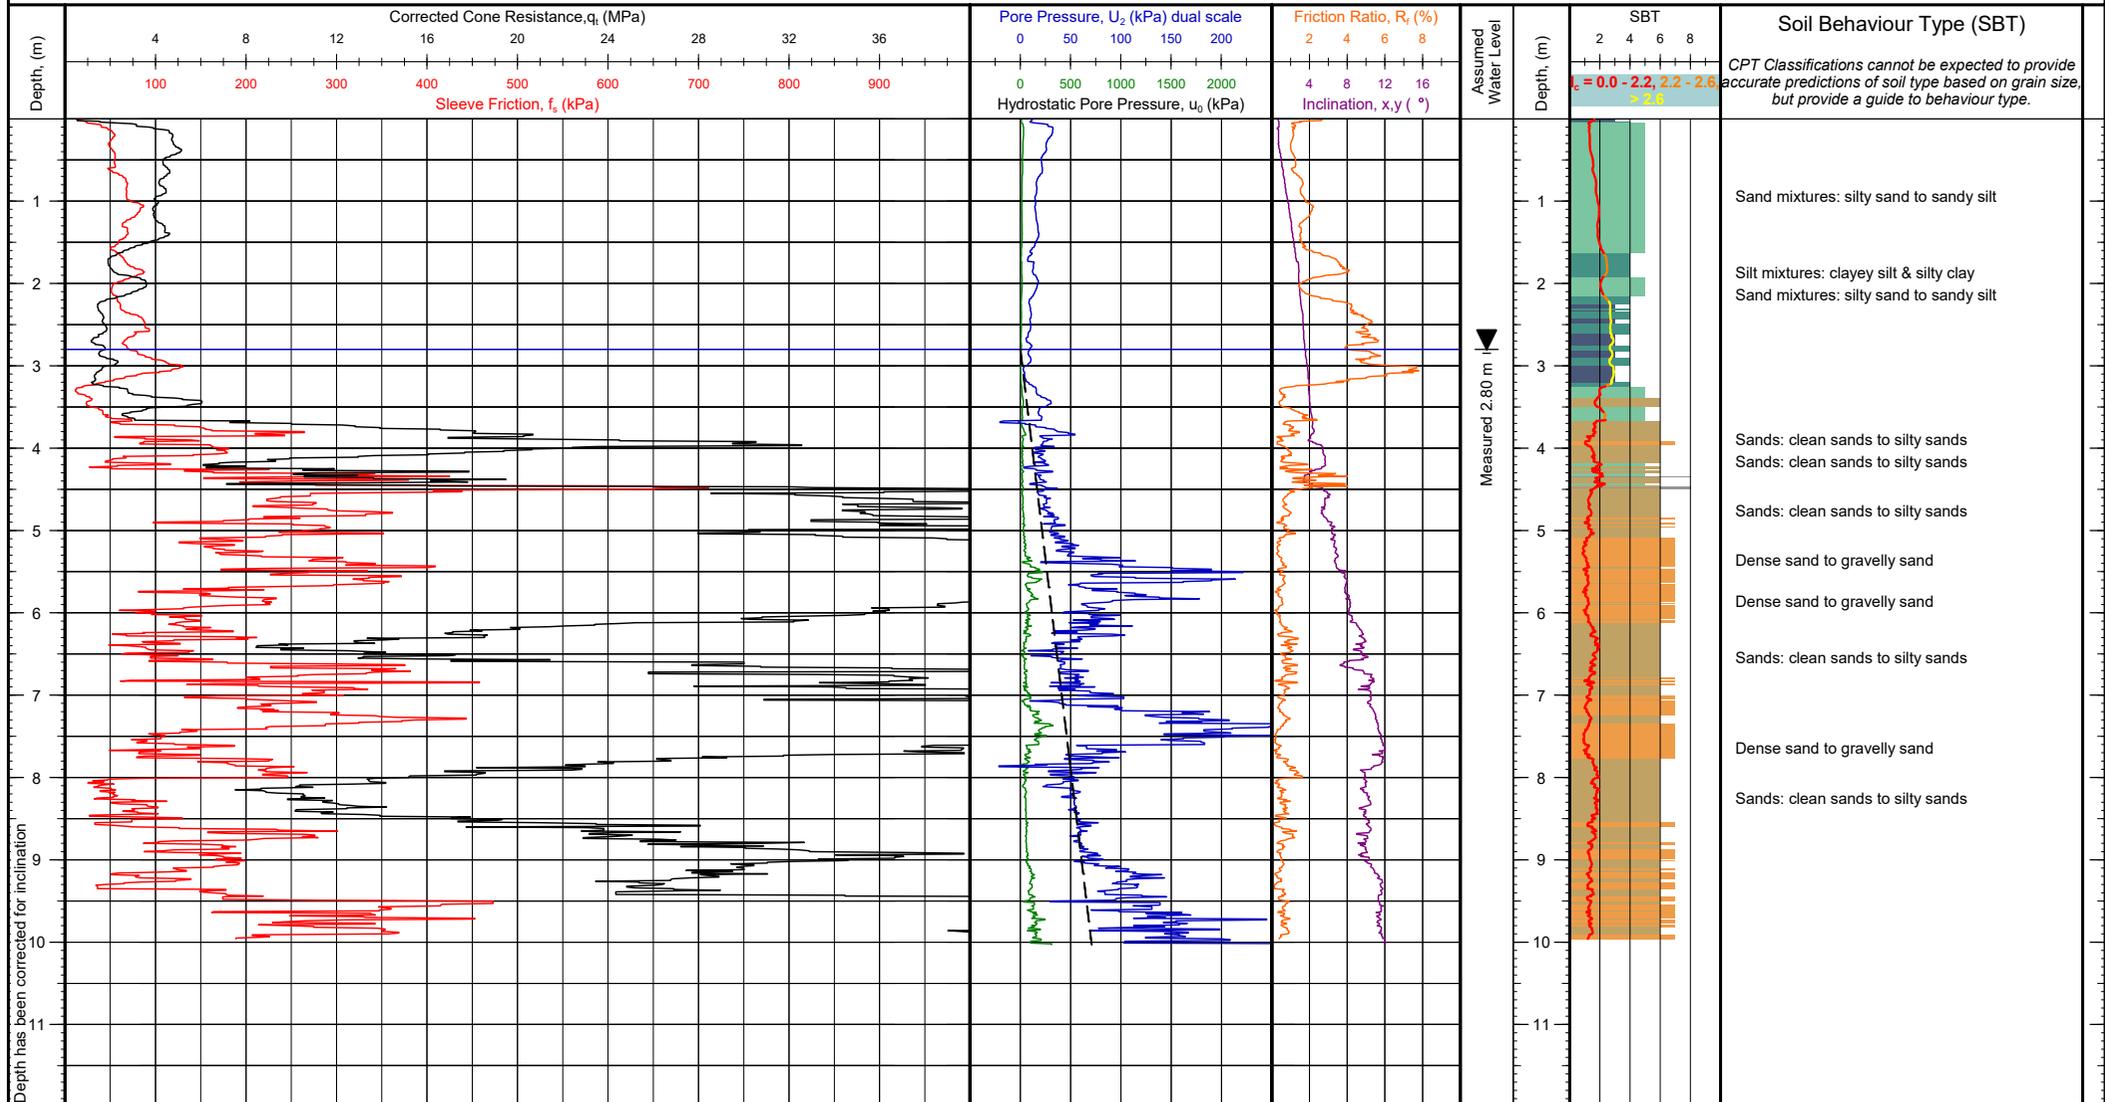
# CONE PENETRATION TEST (CPT) LOG

<b>Client:</b> KGA Geotechnical	<b>Operator:</b> John Cresswell	<b>NZTM 2000 N, E (m):</b> 5187340.74, 1567405.08	<b>Elevation (m):</b> Unknown	<b>Client Reference:</b>
<b>Project:</b> 232 Styx Mill Road	<b>Cone Ref:</b> MKJ335	<b>WGS84 (deg):</b> -43.466135, 172.597044	<b>Date of Test:</b> 17/05/2021	
<b>Location:</b> Casebrook, Christchurch	<b>Cone Type:</b> 10cm <sup>2</sup> Compression	<b>Location Method:</b> Handheld GPS	<b>Depth (m):</b> 10.03	<b>Test Number:</b> <b>CPT-04</b>
<b>Engineer:</b> Abilio Nogueira	<b>Area Ratio:</b> 0.78	<b>Surveyor:</b>	<b>Pre Drill (m):</b> N/A	
<b>Contractor:</b> Ground Investigation Ltd	<b>Filter Type:</b> u <sub>2</sub>	<b>Termination Reason:</b> Target depth		<b>G.I. Job Ref:</b> 210503

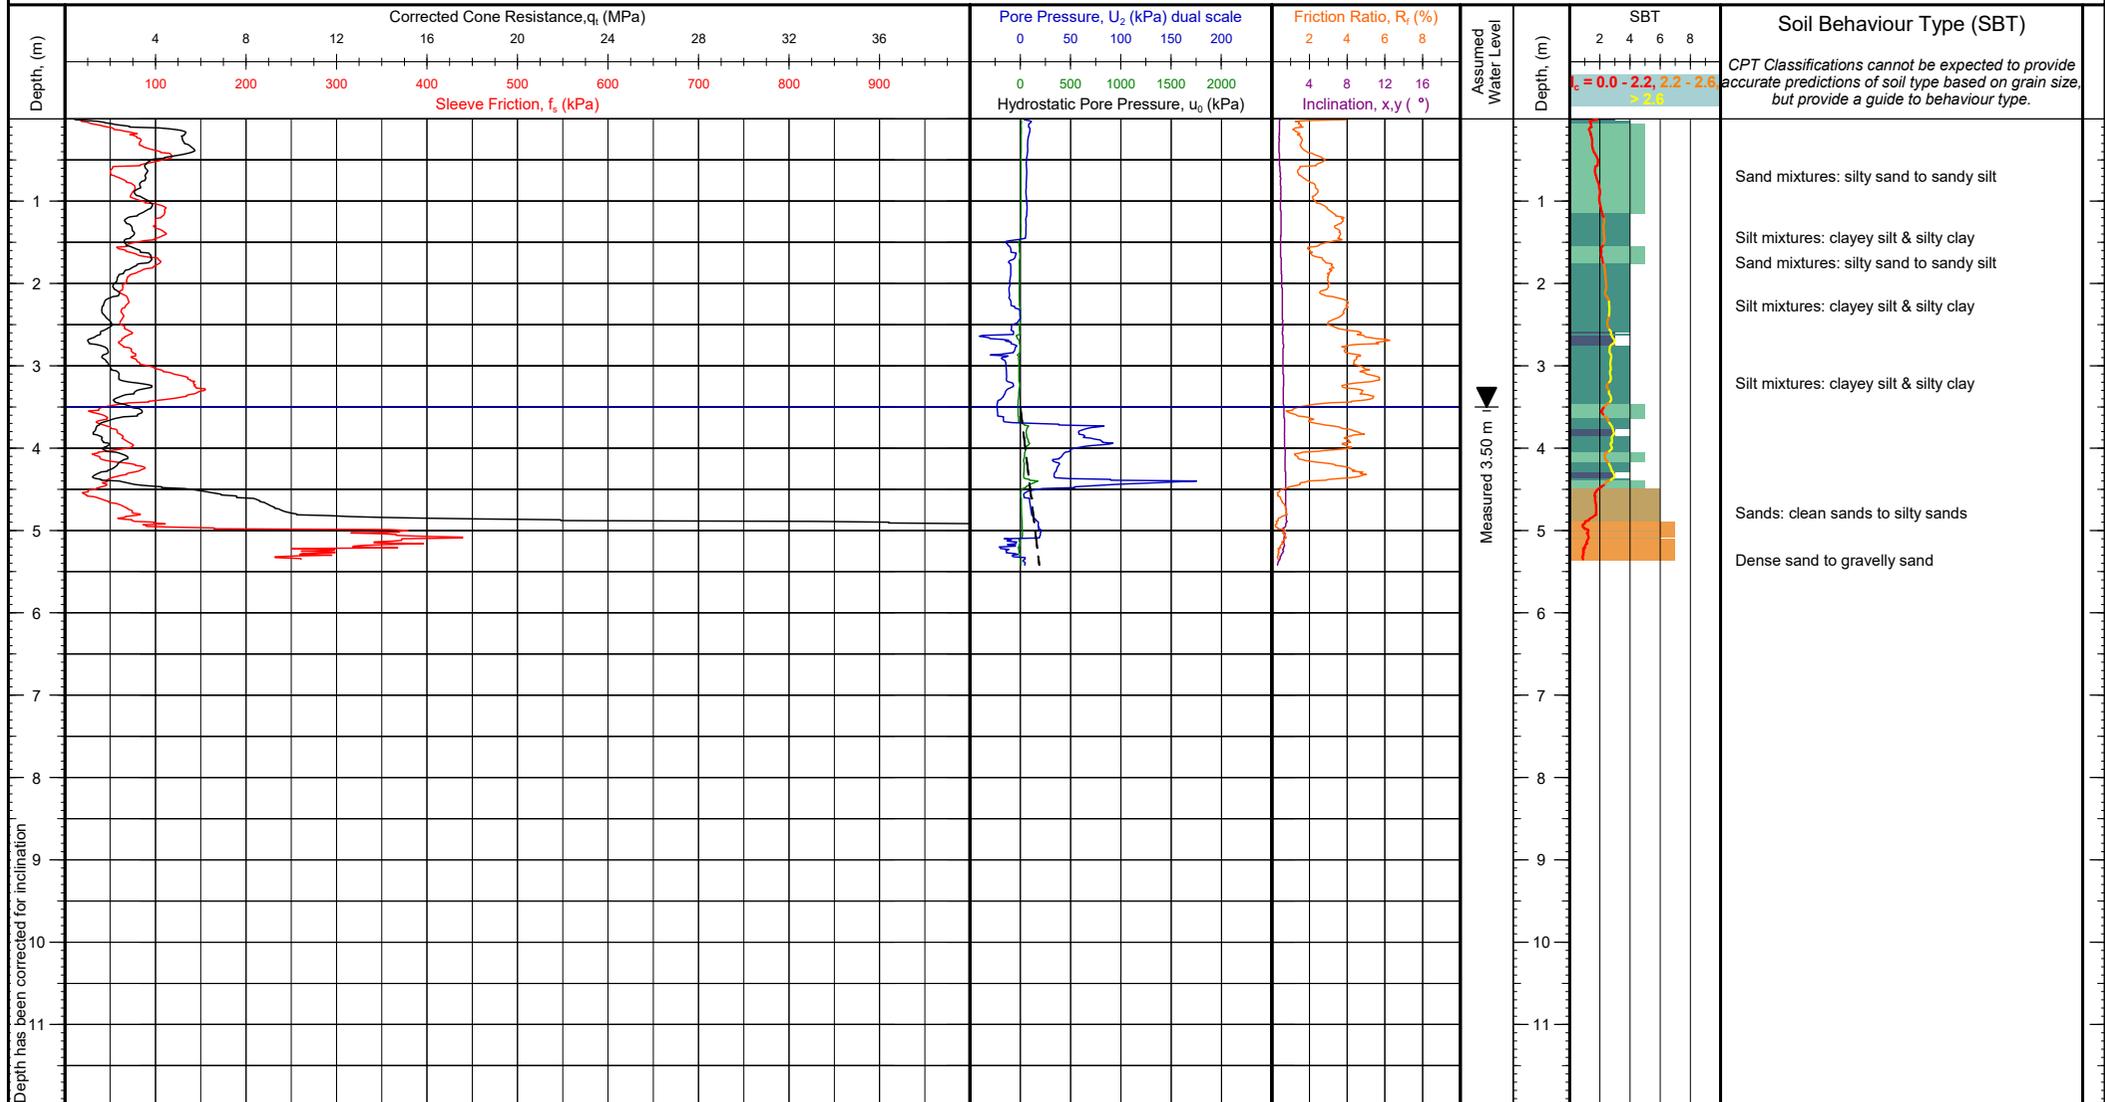
# CONE PENETRATION TEST (CPT) LOG

<b>Client:</b> KGA Geotechnical	<b>Operator:</b> John Cresswell	<b>NZTM 2000 N, E (m):</b> 5187383.17, 1567452.35	<b>Elevation (m):</b> Unknown	<b>Client Reference:</b>
<b>Project:</b> 232 Styx Mill Road	<b>Cone Ref:</b> MKJ539	<b>WGS84 (deg):</b> -43.465755, 172.597631	<b>Date of Test:</b> 17/05/2021	<b>Test Number:</b> <b>CPT-05</b>
<b>Location:</b> Casebrook, Christchurch	<b>Cone Type:</b> 10cm <sup>2</sup> Compression	<b>Location Method:</b> Handheld GPS	<b>Depth (m):</b> 5.42	
<b>Engineer:</b> Abilio Nogueira	<b>Area Ratio:</b> 0.79	<b>Surveyor:</b>	<b>Pre Drill (m):</b> N/A	<b>G.I. Job Ref:</b> 210503
<b>Contractor:</b> Ground Investigation Ltd	<b>Filter Type:</b> $u_2$	<b>Termination Reason:</b> High cone end resistance

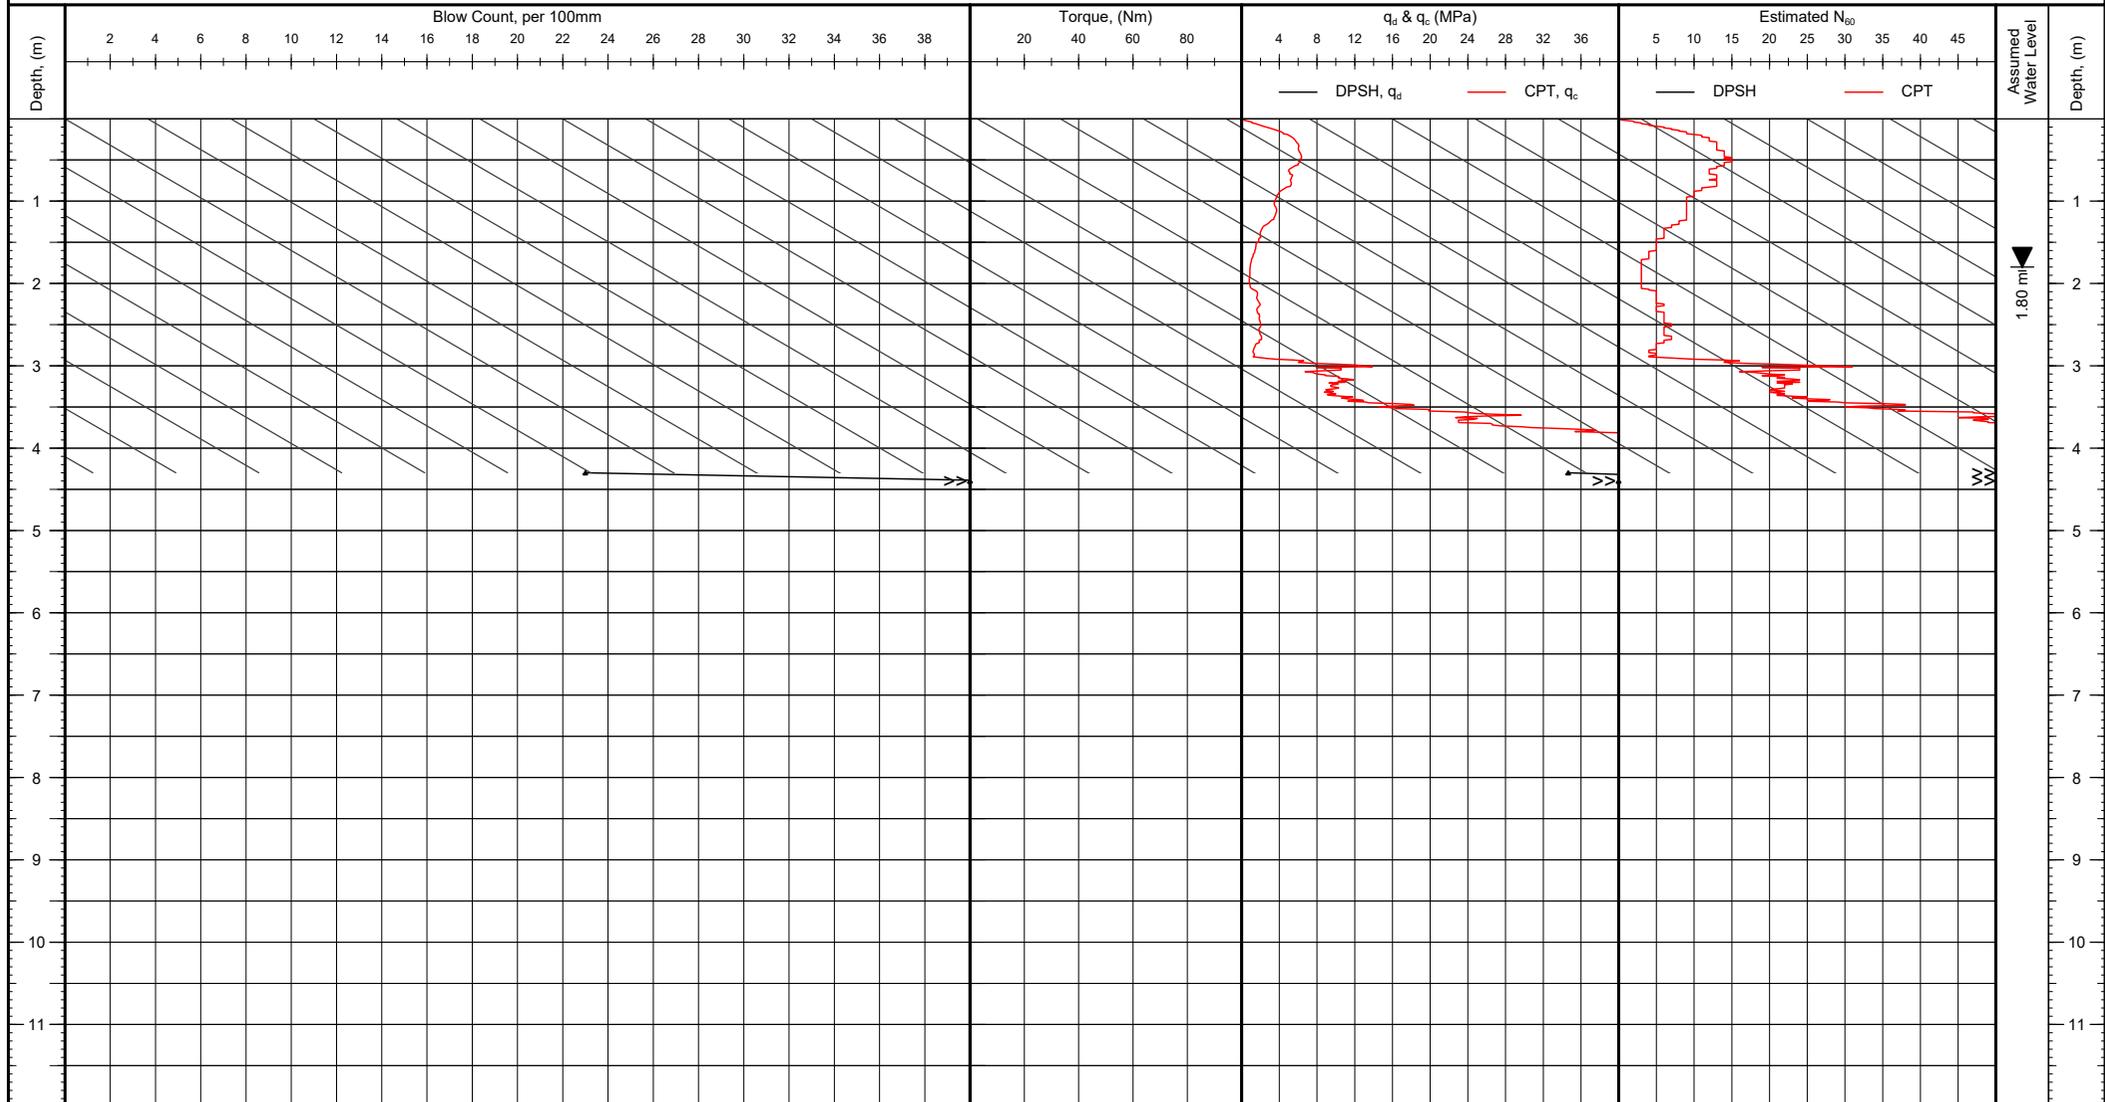
# DYNAMIC PROBE SUPER HEAVY (DPSH) LOG

<b>Client:</b> KGA Geotechnical	<b>Hammer Mass:</b> 63.5 kg	<b>NZTM 2000 N, E (m):</b> 5187237.48, 1567296.37	<b>Elevation (m):</b> Unknown	<b>Client Reference:</b>
<b>Project:</b> 232 Styx Mill Road	<b>Rod Mass:</b> 6.2 kg/m	<b>WGS84 (deg):</b> -43.467060, 172.595694	<b>Date of Test:</b> 18/05/2021	<b>Test Number: DPSH-01</b>
<b>Location:</b> Casebrook, Christchurch	<b>Energy Efficiency:</b> 96%	<b>Location Method:</b> Handheld GPS	<b>Depth (m):</b> 4.40	
<b>Engineer:</b> Abilio Nogueira	<b>Measured Energy:</b> 448.51	<b>Surveyor:</b>	<b>Pre Drill (m):</b> 4.30 m	<b>G.I. Job Ref:</b> 210503
<b>Contractor:</b> Ground Investigation Ltd	<b>Cone Area:</b> 0.002	<b>Termination Reason:</b> Very high blow count

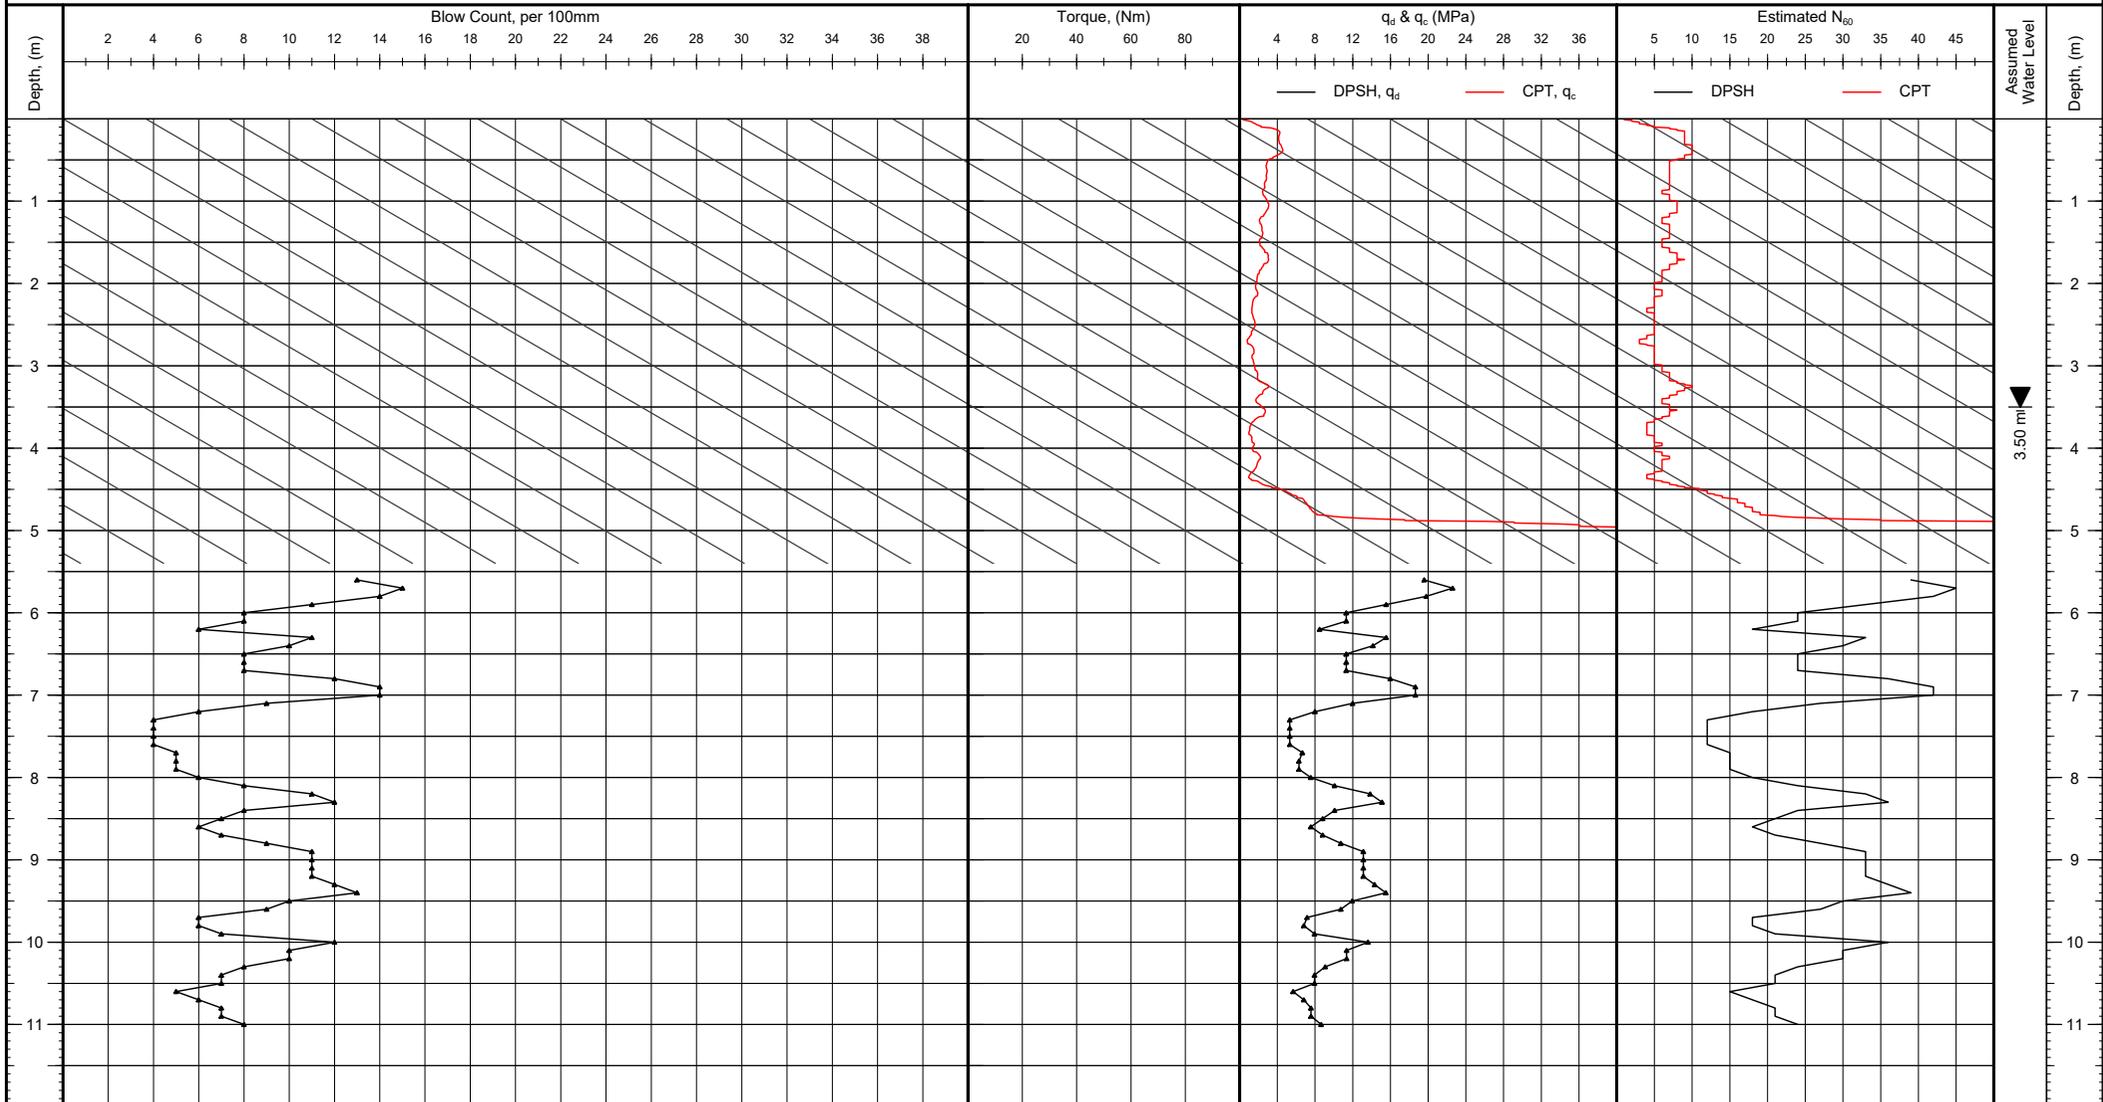
# DYNAMIC PROBE SUPER HEAVY (DPSH) LOG

<b>Client:</b> KGA Geotechnical	<b>Hammer Mass:</b> 63.5 kg	<b>NZTM 2000 N, E (m):</b> 5187381.84, 1567451.88	<b>Elevation (m):</b> Unknown	<b>Client Reference:</b>
<b>Project:</b> 232 Styx Mill Road	<b>Rod Mass:</b> 6.2 kg/m	<b>WGS84 (deg):</b> -43.465767, 172.597625	<b>Date of Test:</b> 18/05/2021	<b>Test Number: DPSH-05</b>
<b>Location:</b> Casebrook, Christchurch	<b>Energy Efficiency:</b> 96%	<b>Location Method:</b> Handheld GPS	<b>Depth (m):</b> 11.00	
<b>Engineer:</b> Abilio Nogueira	<b>Measured Energy:</b> 448.51	<b>Surveyor:</b>	<b>Pre Drill (m):</b> 5.40 m	<b>G.I. Job Ref:</b> 210503
<b>Contractor:</b> Ground Investigation Ltd	<b>Cone Area:</b> 0.002	<b>Termination Reason:</b> Target depth
