# Land Information Memorandum

Property address:  
250 Styx Mill Road

LIM number: H00892132  
Page 1

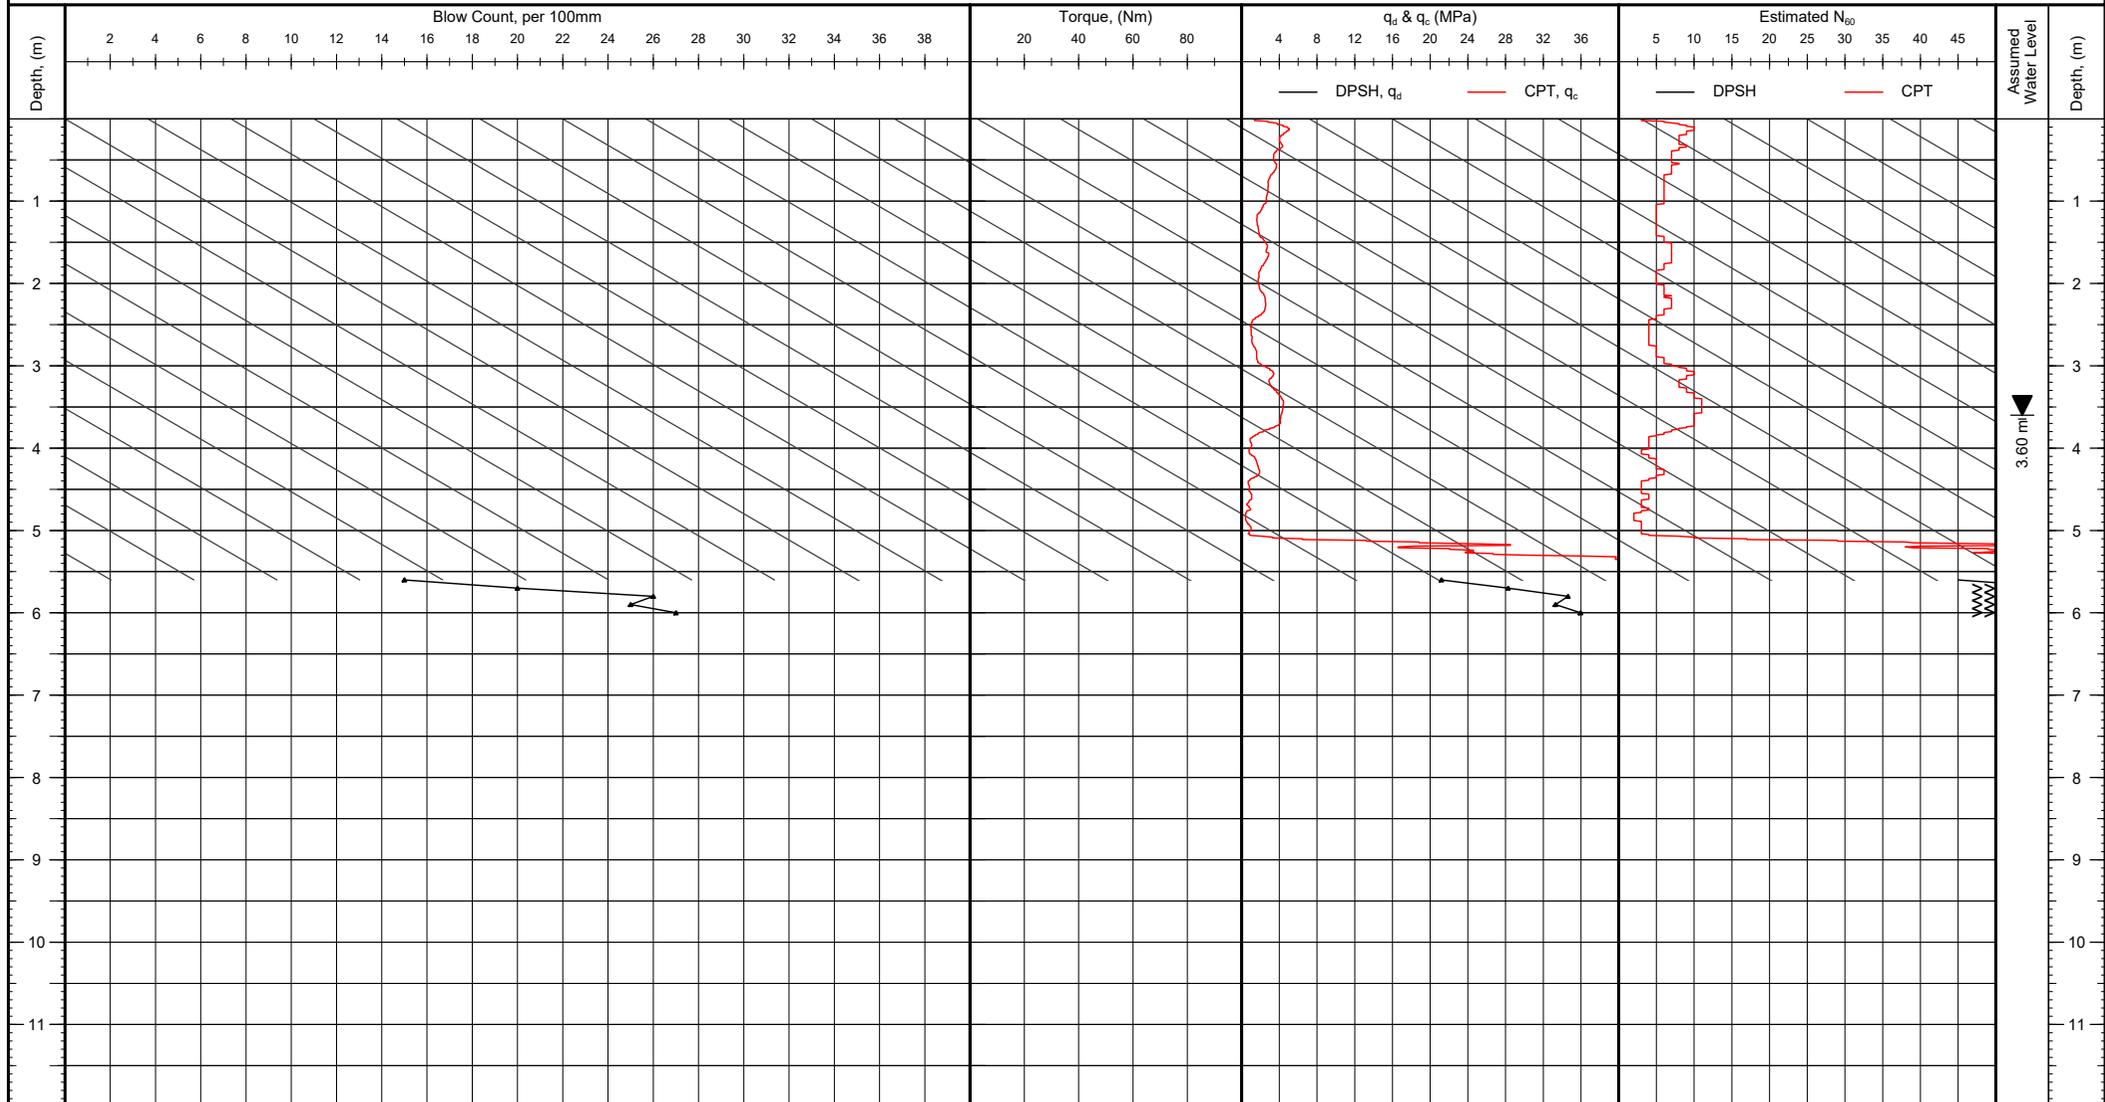
# DYNAMIC PROBE SUPER HEAVY (DPSH) LOG

<b>Client:</b> KGA Geotechnical	<b>Hammer Mass:</b> 63.5 kg	<b>NZTM 2000 N, E (m):</b> 5187336.06, 1567472.08	<b>Elevation (m):</b> Unknown	<b>Client Reference:</b>
<b>Project:</b> 232 Styx Mill Road	<b>Rod Mass:</b> 6.2 kg/m	<b>WGS84 (deg):</b> -43.466180, 172.597872	<b>Date of Test:</b> 18/05/2021	<b>Test Number: DPSH-06</b>
<b>Location:</b> Casebrook, Christchurch	<b>Energy Efficiency:</b> 96%	<b>Location Method:</b> Handheld GPS	<b>Depth (m):</b> 6.00	
<b>Engineer:</b> Abilio Nogueira	<b>Measured Energy:</b> 448.51	<b>Surveyor:</b>	<b>Pre Drill (m):</b> 5.60 m	<b>G.I. Job Ref:</b> 210503
<b>Contractor:</b> Ground Investigation Ltd	<b>Cone Area:</b> 0.002	<b>Termination Reason:</b> Consistant high blow count		
<b>Comments:</b> Continued from CPT-06

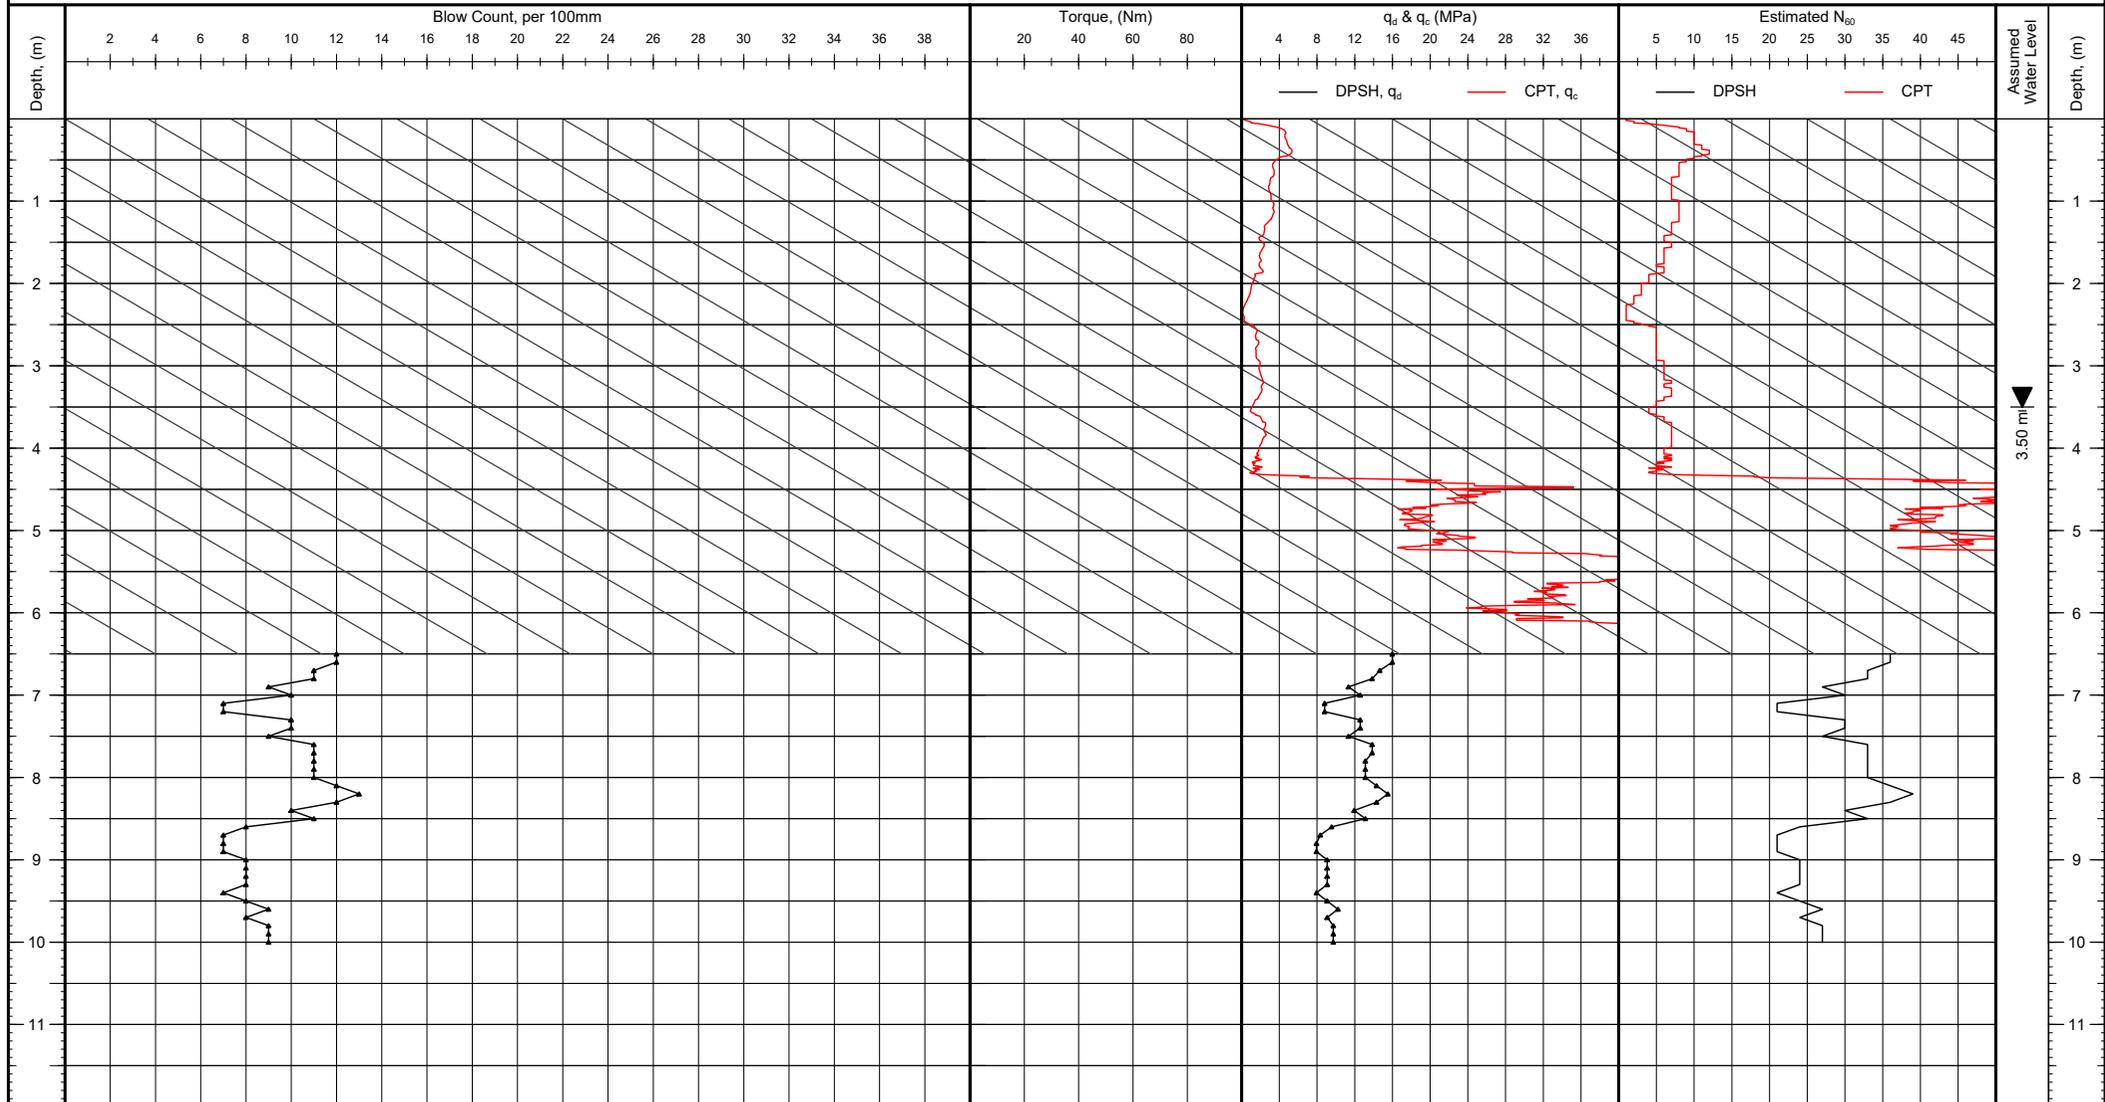
# DYNAMIC PROBE SUPER HEAVY (DPSH) LOG

<b>Client:</b> KGA Geotechnical	<b>Hammer Mass:</b> 63.5 kg	<b>NZTM 2000 N, E (m):</b> 5187315.45, 1567503.40	<b>Elevation (m):</b> Unknown	<b>Client Reference:</b>
<b>Project:</b> 232 Styx Mill Road	<b>Rod Mass:</b> 6.2 kg/m	<b>WGS84 (deg):</b> -43.466367, 172.598258	<b>Date of Test:</b> 18/05/2021	<b>Test Number: DPSH-07</b>
<b>Location:</b> Casebrook, Christchurch	<b>Energy Efficiency:</b> 96%	<b>Location Method:</b> Handheld GPS	<b>Depth (m):</b> 10.00	
<b>Engineer:</b> Abilio Nogueira	<b>Measured Energy:</b> 448.51	<b>Surveyor:</b>	<b>Pre Drill (m):</b> 6.50 m	<b>G.I. Job Ref:</b> 210503
<b>Contractor:</b> Ground Investigation Ltd	<b>Cone Area:</b> 0.002	<b>Termination Reason:</b> Target depth

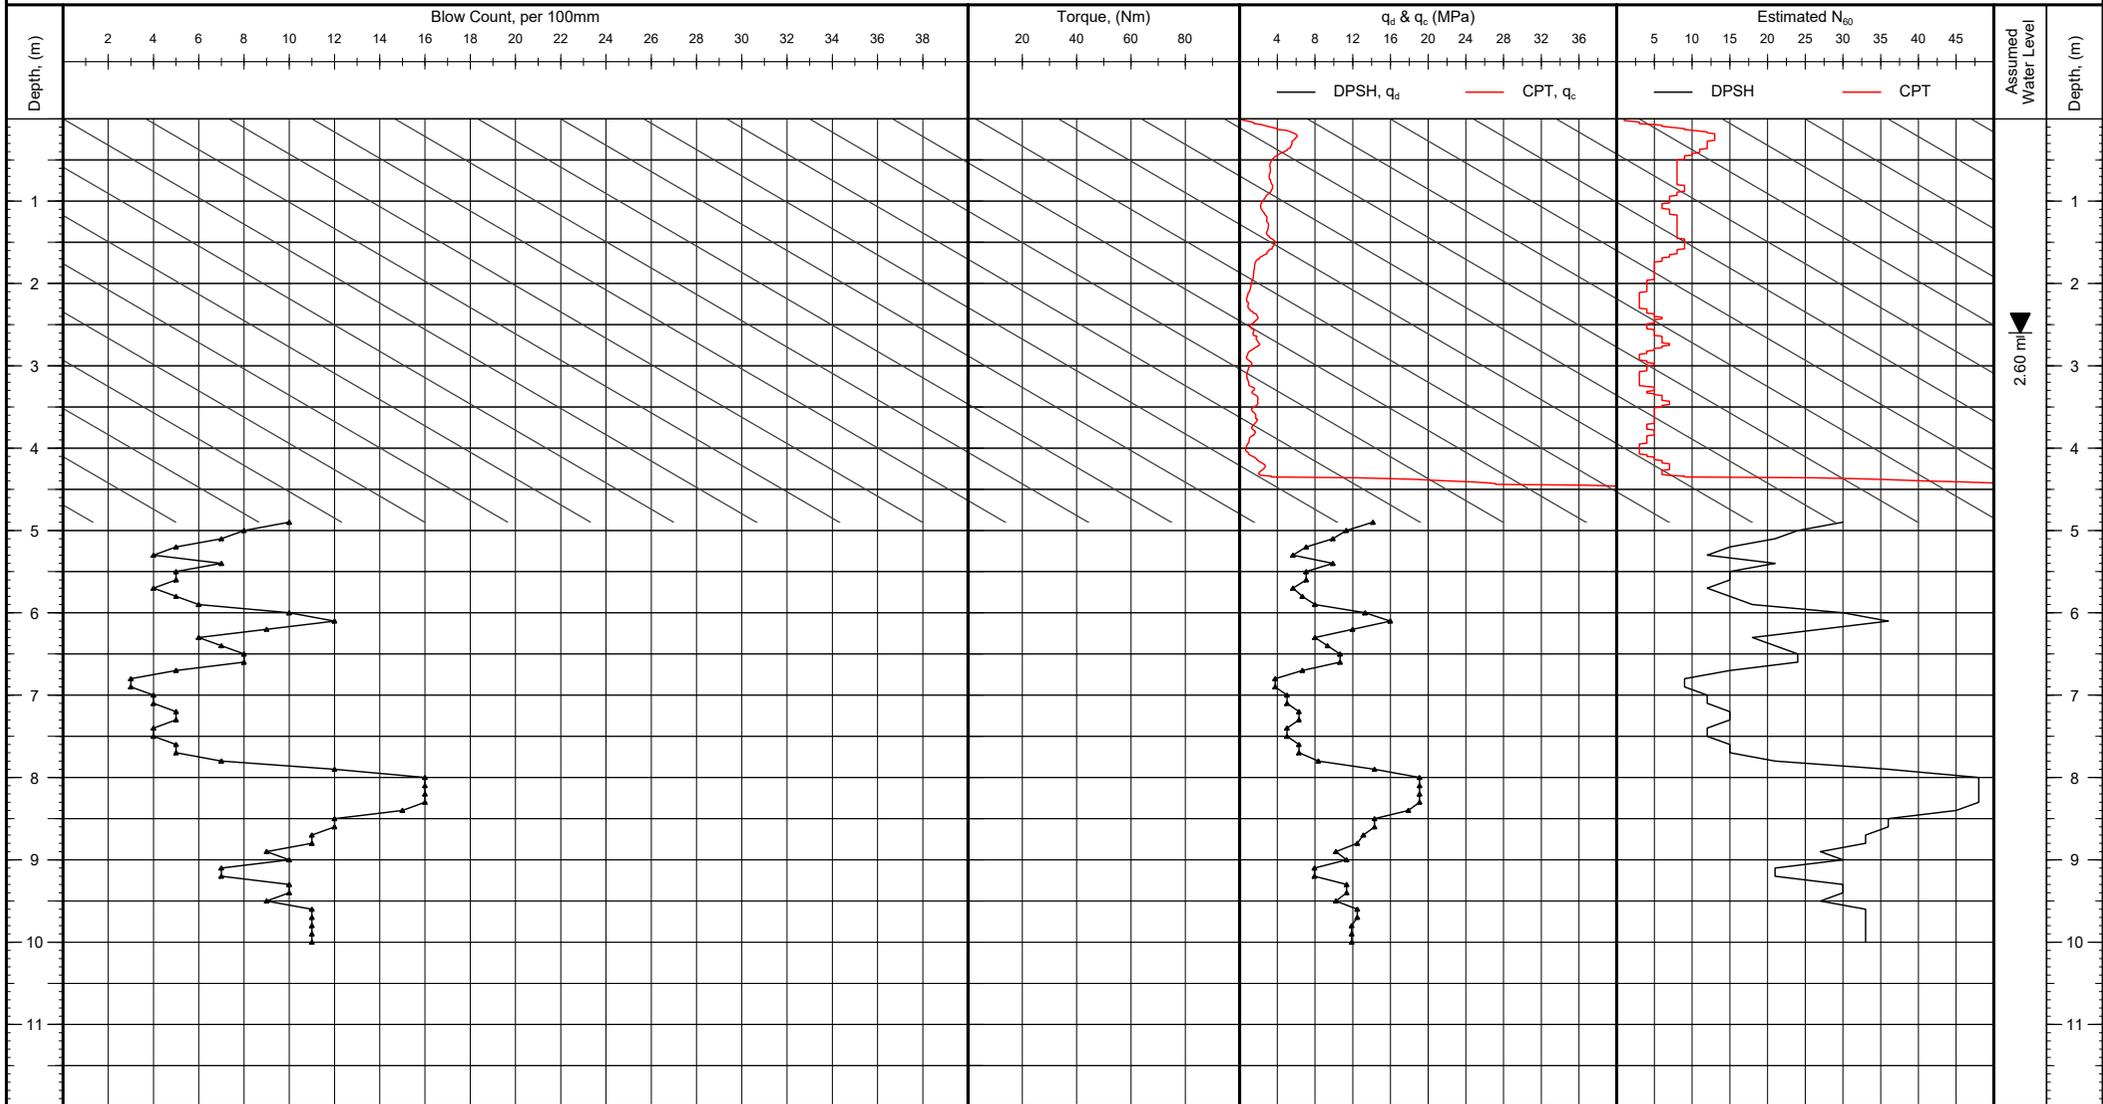
# DYNAMIC PROBE SUPER HEAVY (DPSH) LOG

<b>Client:</b> KGA Geotechnical	<b>Hammer Mass:</b> 63.5 kg	<b>NZTM 2000 N, E (m):</b> 5187248.52, 1567442.81	<b>Elevation (m):</b> Unknown	<b>Client Reference:</b>
<b>Project:</b> 232 Styx Mill Road	<b>Rod Mass:</b> 6.2 kg/m	<b>WGS84 (deg):</b> -43.466967, 172.597505	<b>Date of Test:</b> 18/05/2021	<b>Test Number: DPSH-09</b>
<b>Location:</b> Casebrook, Christchurch	<b>Energy Efficiency:</b> 96%	<b>Location Method:</b> Handheld GPS	<b>Depth (m):</b> 10.00	
<b>Engineer:</b> Abilio Nogueira	<b>Measured Energy:</b> 448.51	<b>Surveyor:</b>	<b>Pre Drill (m):</b> 4.90 m	<b>G.I. Job Ref:</b> 210503
<b>Contractor:</b> Ground Investigation Ltd	<b>Cone Area:</b> 0.002	<b>Termination Reason:</b> Target depth		
<b>Comments:</b> Continued from CPT-09

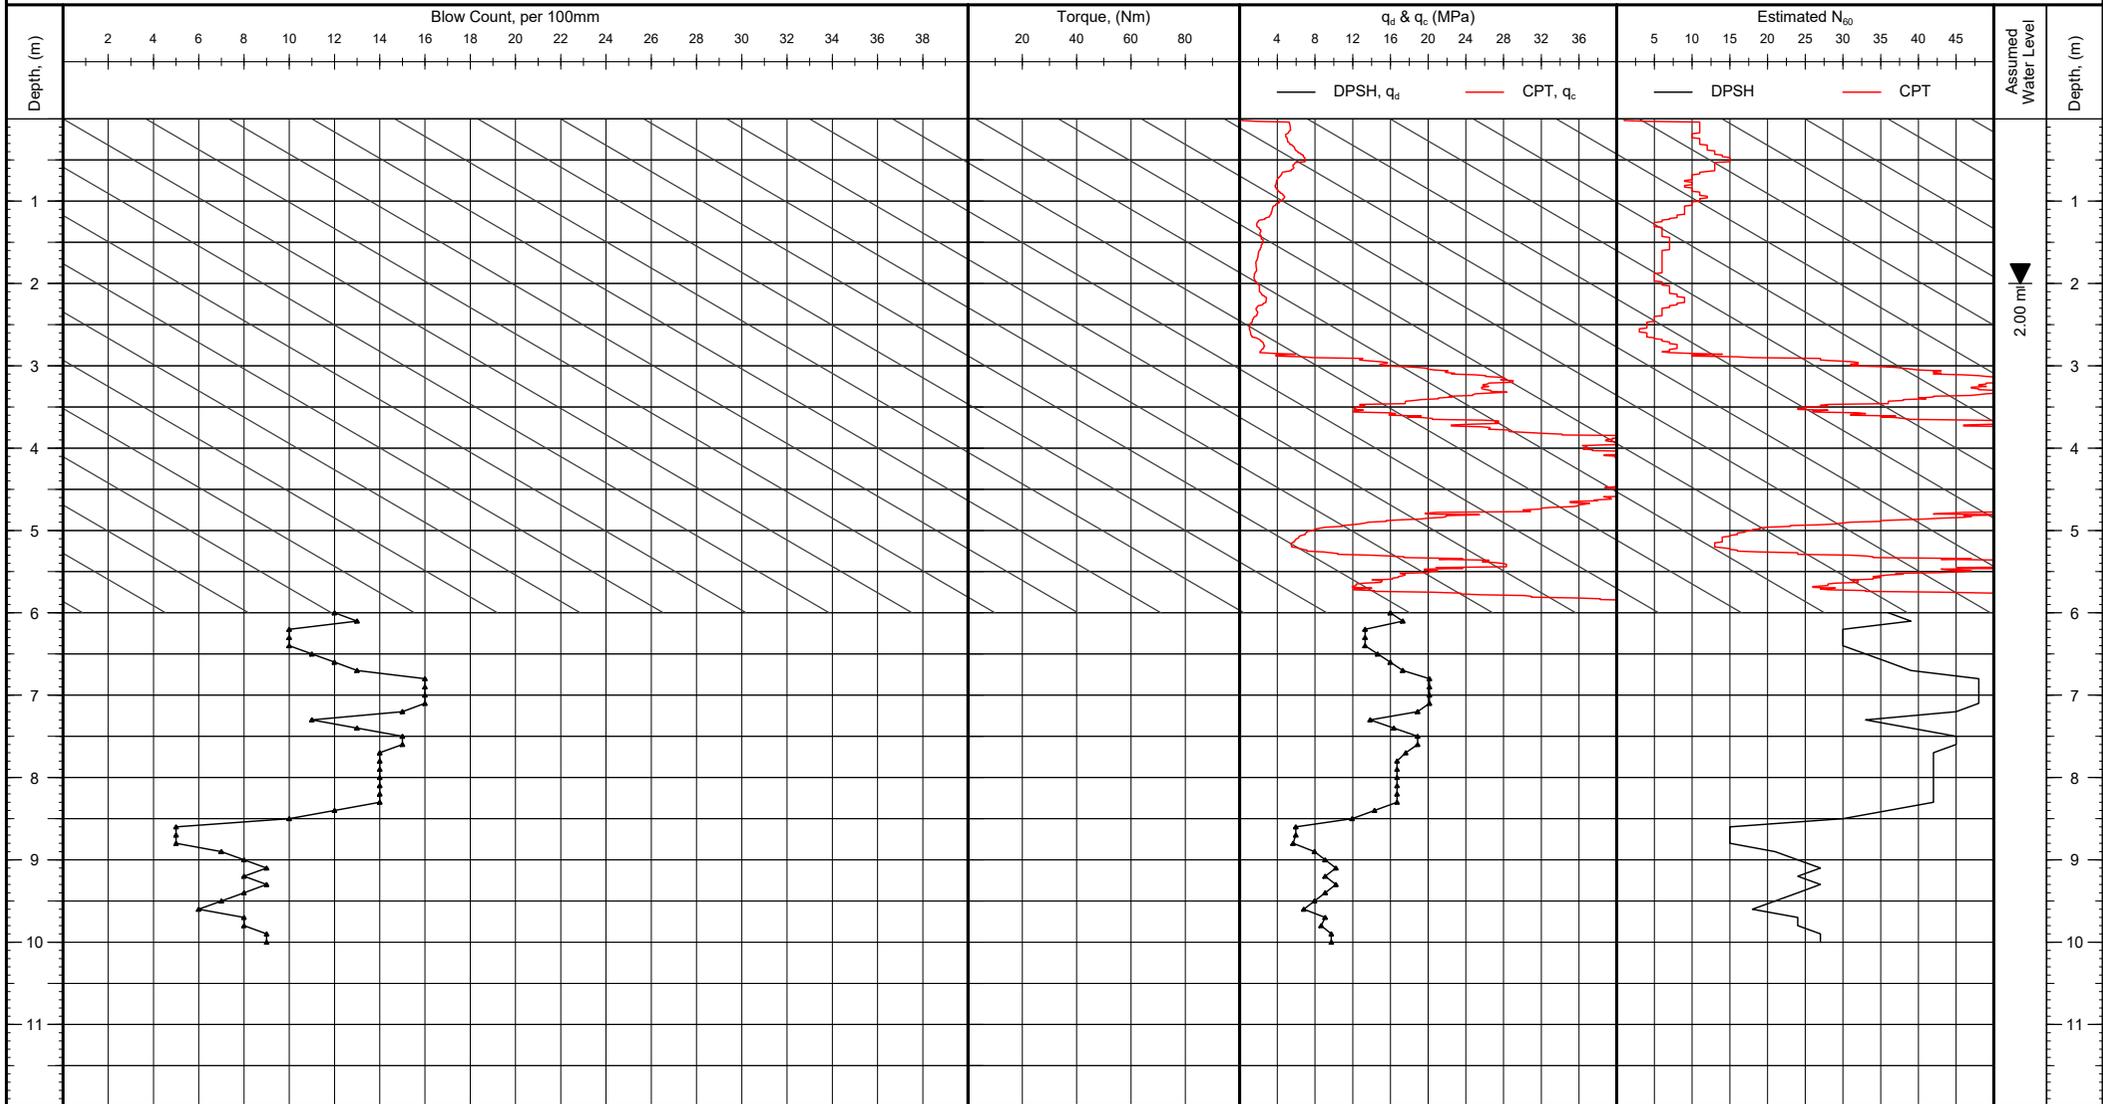
# DYNAMIC PROBE SUPER HEAVY (DPSH) LOG

<b>Client:</b> KGA Geotechnical	<b>Hammer Mass:</b> 63.5 kg	<b>NZTM 2000 N, E (m):</b> 5187237.82, 1567366.75	<b>Elevation (m):</b> Unknown	<b>Client Reference:</b>
<b>Project:</b> 232 Styx Mill Road	<b>Rod Mass:</b> 6.2 kg/m	<b>WGS84 (deg):</b> -43.467060, 172.596564	<b>Date of Test:</b> 18/05/2021	<b>Test Number: DPSH-10</b>
<b>Location:</b> Casebrook, Christchurch	<b>Energy Efficiency:</b> 96%	<b>Location Method:</b> Handheld GPS	<b>Depth (m):</b> 10.00	
<b>Engineer:</b> Abilio Nogueira	<b>Measured Energy:</b> 448.51	<b>Surveyor:</b>	<b>Pre Drill (m):</b> 6.00 m	<b>G.I. Job Ref:</b> 210503
<b>Contractor:</b> Ground Investigation Ltd	<b>Cone Area:</b> 0.002	<b>Termination Reason:</b> Target depth		
<b>Comments:</b> Continued from CPT-10

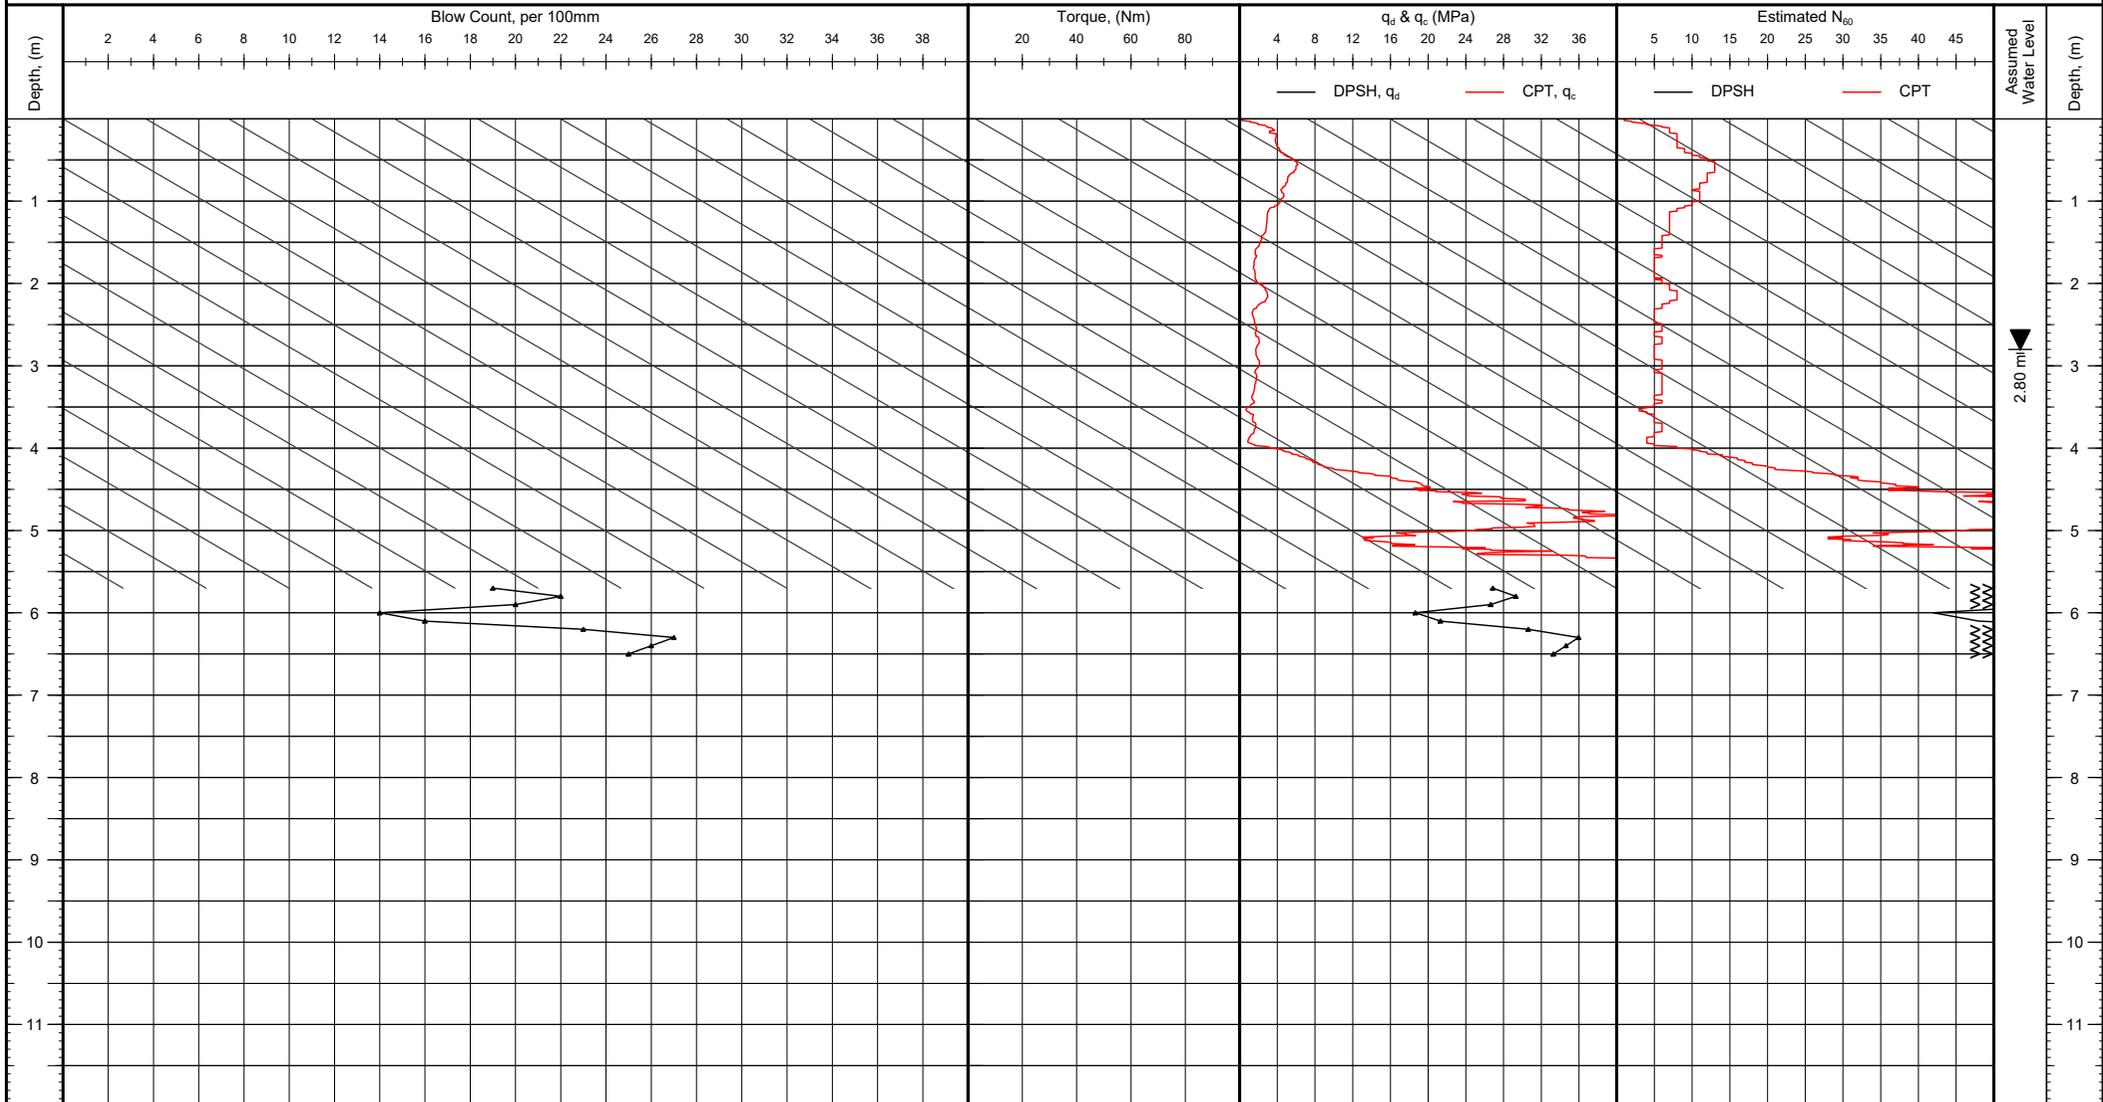
# DYNAMIC PROBE SUPER HEAVY (DPSH) LOG

<b>Client:</b> KGA Geotechnical	<b>Hammer Mass:</b> 63.5 kg	<b>NZTM 2000 N, E (m):</b> 5187306.52, 1567447.71	<b>Elevation (m):</b> Unknown	<b>Client Reference:</b>
<b>Project:</b> 232 Styx Mill Road	<b>Rod Mass:</b> 6.2 kg/m	<b>WGS84 (deg):</b> -43.466445, 172.597569	<b>Date of Test:</b> 18/05/2021	<b>Test Number: DPSH-12</b>
<b>Location:</b> Casebrook, Christchurch	<b>Energy Efficiency:</b> 96%	<b>Location Method:</b> Handheld GPS	<b>Depth (m):</b> 6.50	
<b>Engineer:</b> Abilio Nogueira	<b>Measured Energy:</b> 448.51	<b>Surveyor:</b>	<b>Pre Drill (m):</b> 5.70 m	<b>G.I. Job Ref:</b> 210503
<b>Contractor:</b> Ground Investigation Ltd	<b>Cone Area:</b> 0.002	<b>Termination Reason:</b> Consistant high blow count

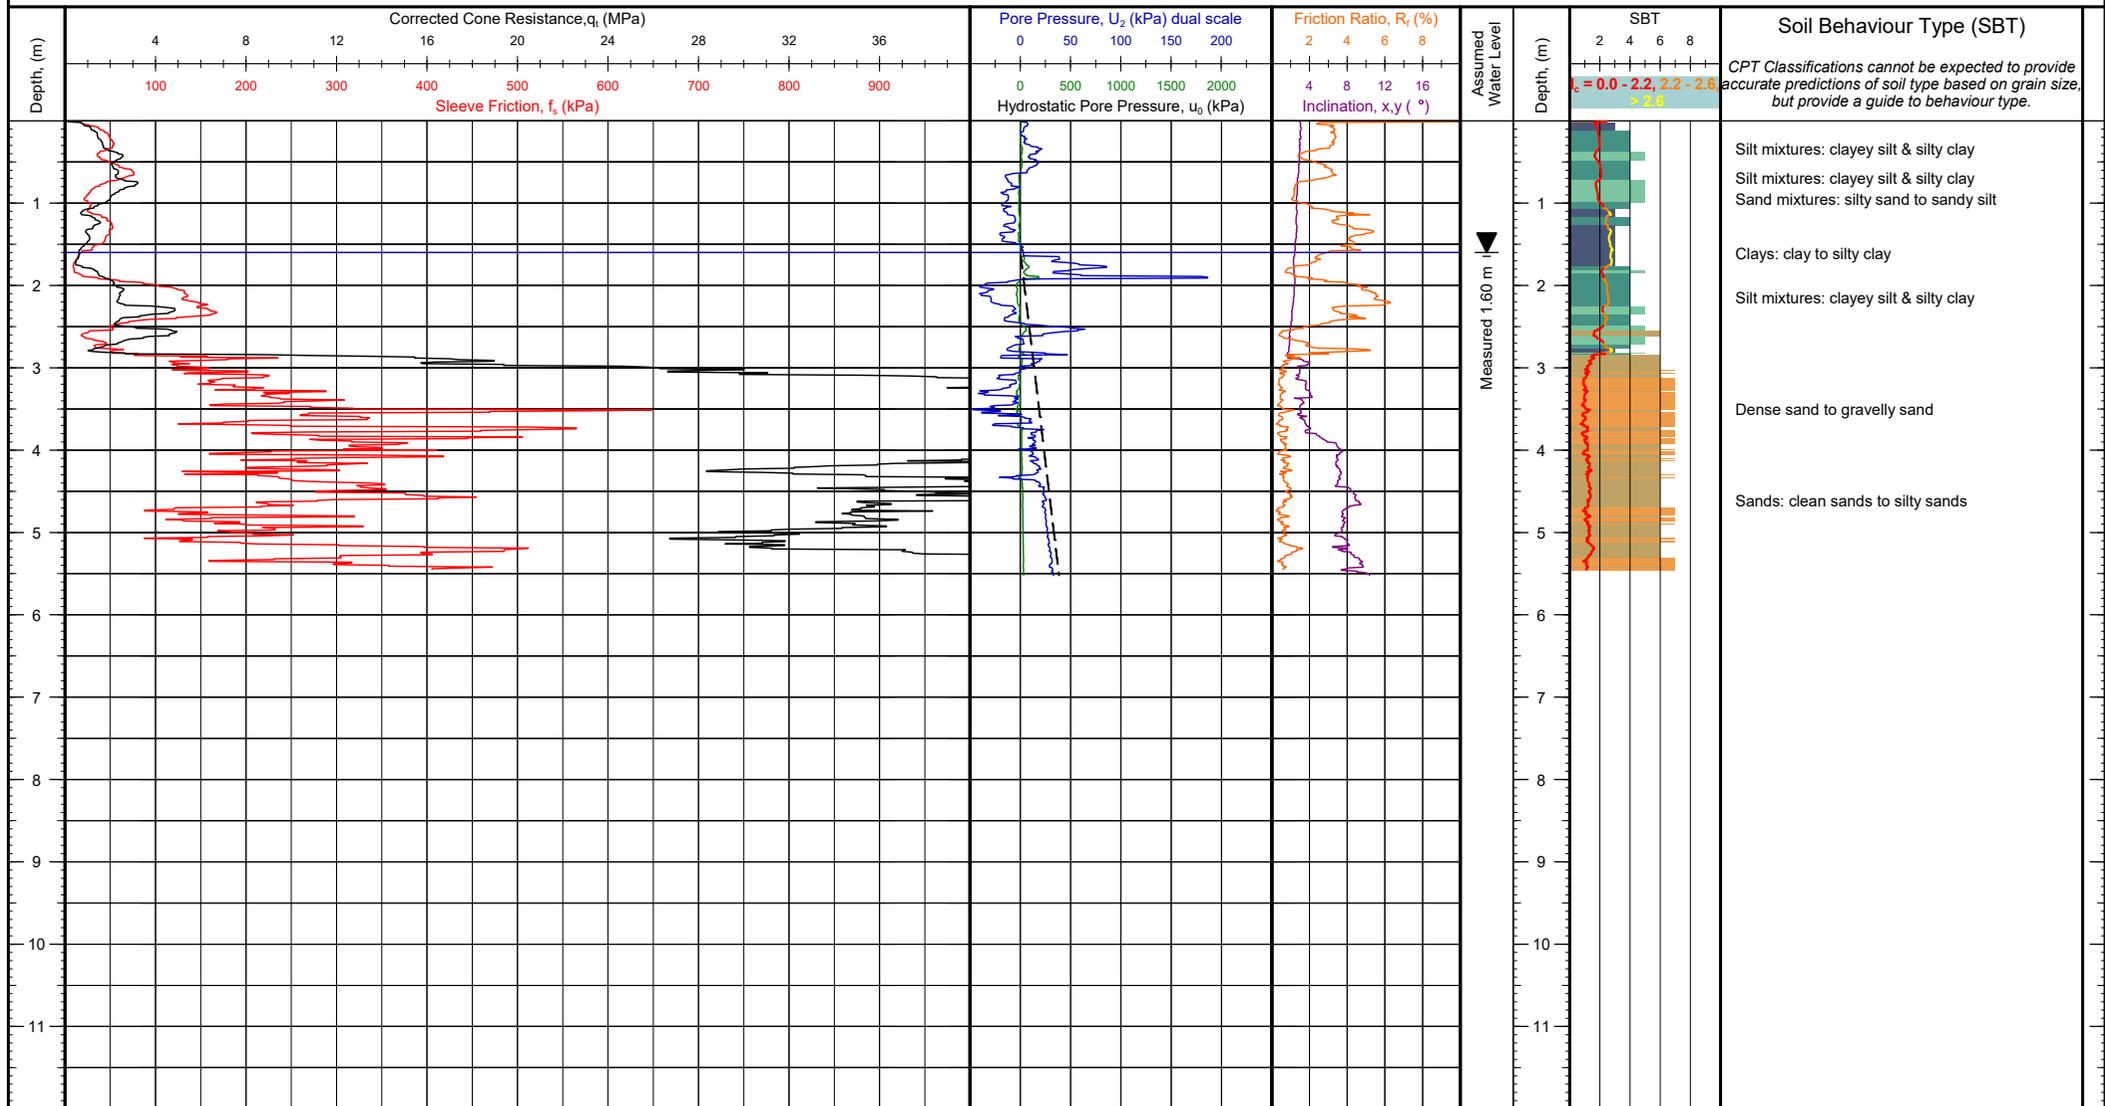
# CONE PENETRATION TEST (CPT) LOG

<b>Client:</b> KGA Geotechnical	<b>Operator:</b> John Cresswell	<b>NZTM 2000 N, E (m):</b> 5187171.40, 1567228.34	<b>Elevation (m):</b> Unknown	<b>Client Reference:</b>
<b>Project:</b> Cnr Styx Mill Road and Highsted Road	<b>Cone Ref:</b> MKJ311	<b>WGS84 (deg):</b> -43.467652, 172.594849	<b>Date of Test:</b> 17/09/2020	<b>Test Number:</b> <b>CPT-04</b>
<b>Location:</b> Casebrook, Christchurch	<b>Cone Type:</b> 10cm <sup>2</sup> Compression	<b>Location Method:</b> Handheld GPS	<b>Depth (m):</b> 5.52	
<b>Engineer:</b> Abilio Nogueira	<b>Area Ratio:</b> 0.8	<b>Surveyor:</b>	<b>Pre Drill (m):</b> N/A	<b>G.I. Job Ref:</b> 200864
<b>Contractor:</b> Ground Investigation Ltd.	<b>Filter Type:</b> $u_2$	<b>Termination Reason:</b> High cone end resistance		
<b>Comments:</b> Continued with DPSH-04

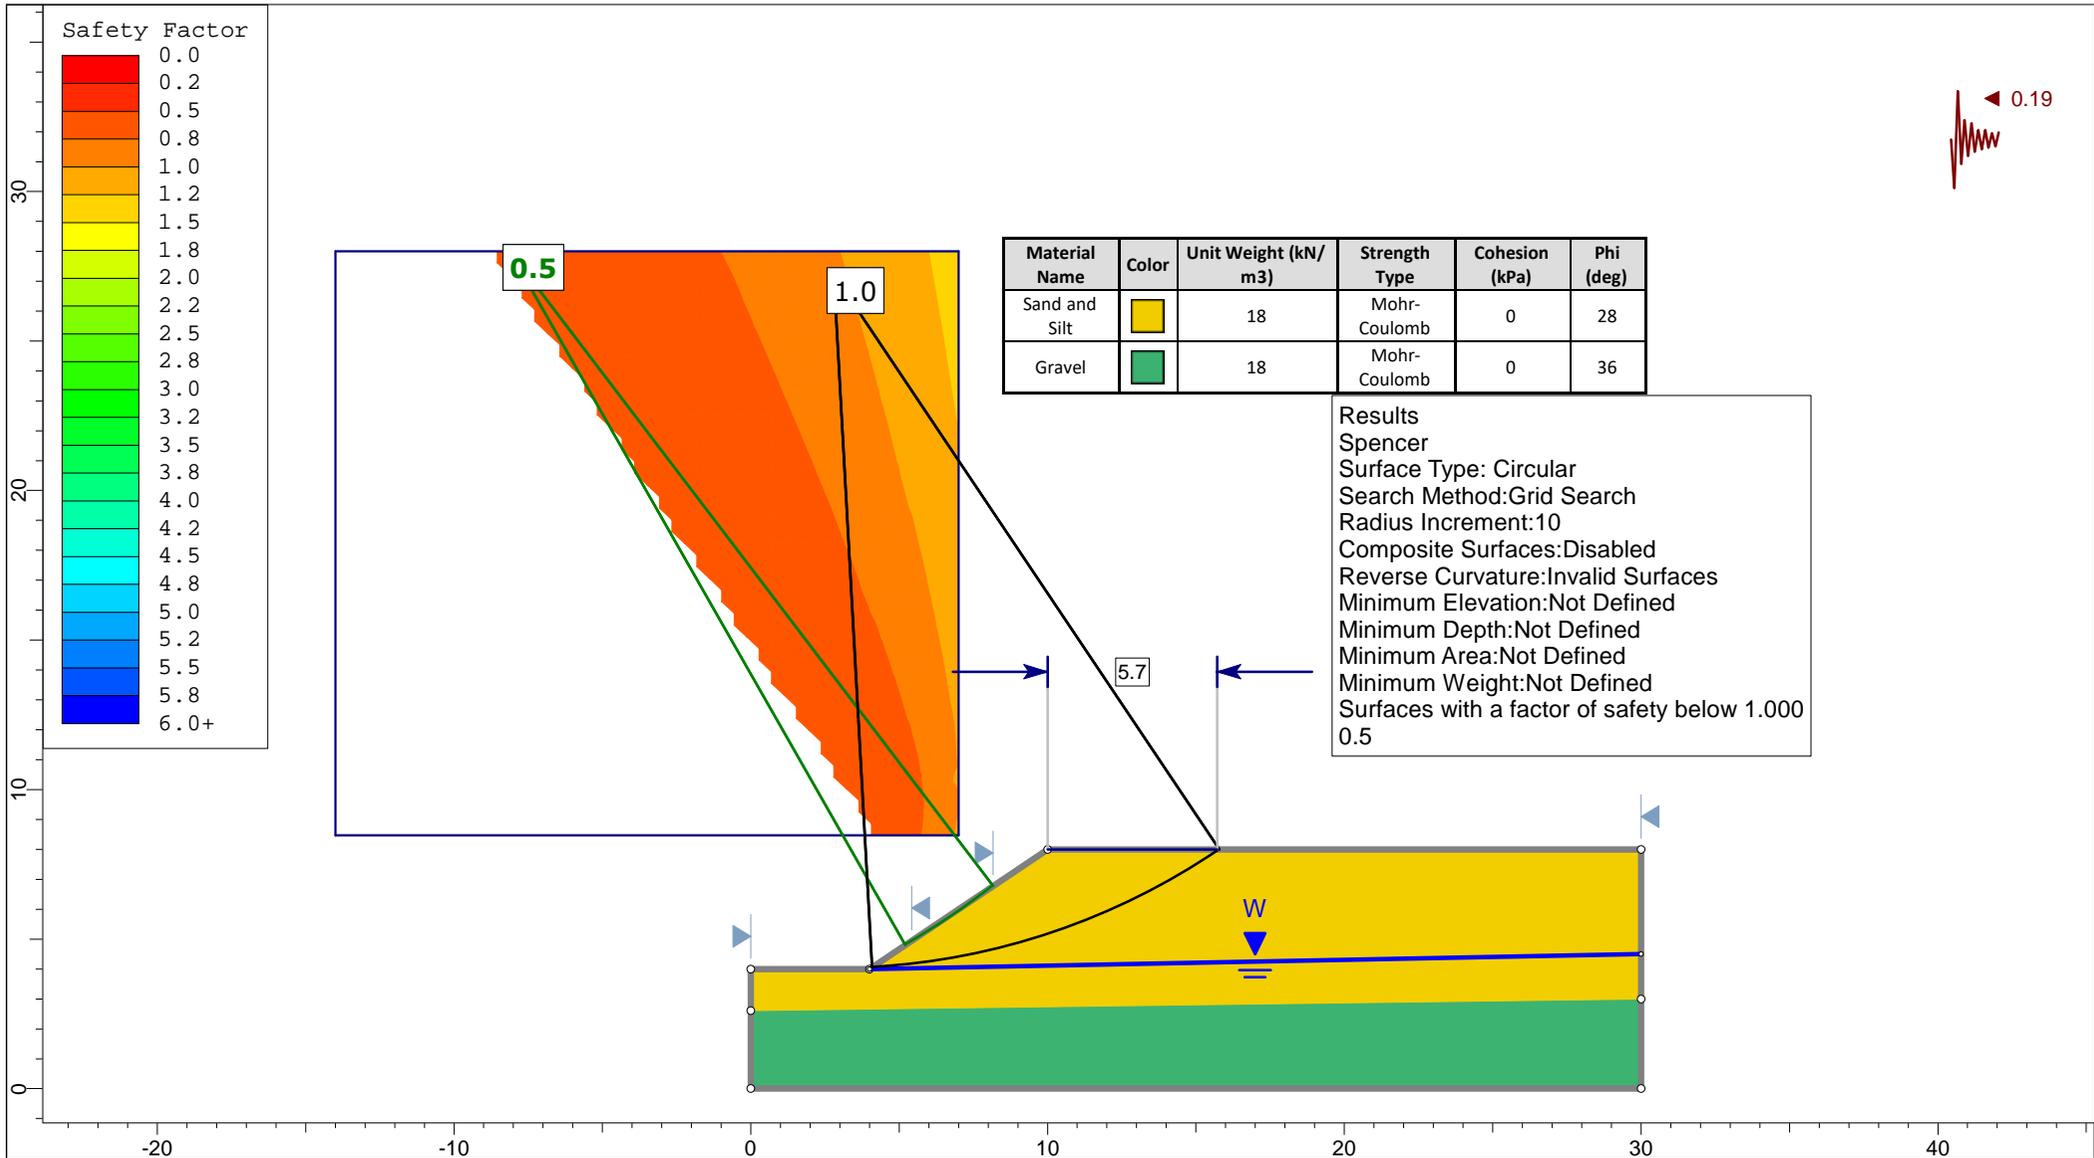
<p>Auckland   Christchurch 09 478 6655   03 343 5302 www.kga.co.nz</p>	<i>Project</i>		K210318 - 232 Styx Mill Road, Casebrook	
	<i>Analysis Description</i>		Seismic SLS - Circular - Measured Groundwater	
	<i>Drawn By</i>	TV	<i>Company</i>	KGA Geotechnical
	<i>Date</i>	27/05/2021	<i>File Name</i>	Seismic SLS.slmd

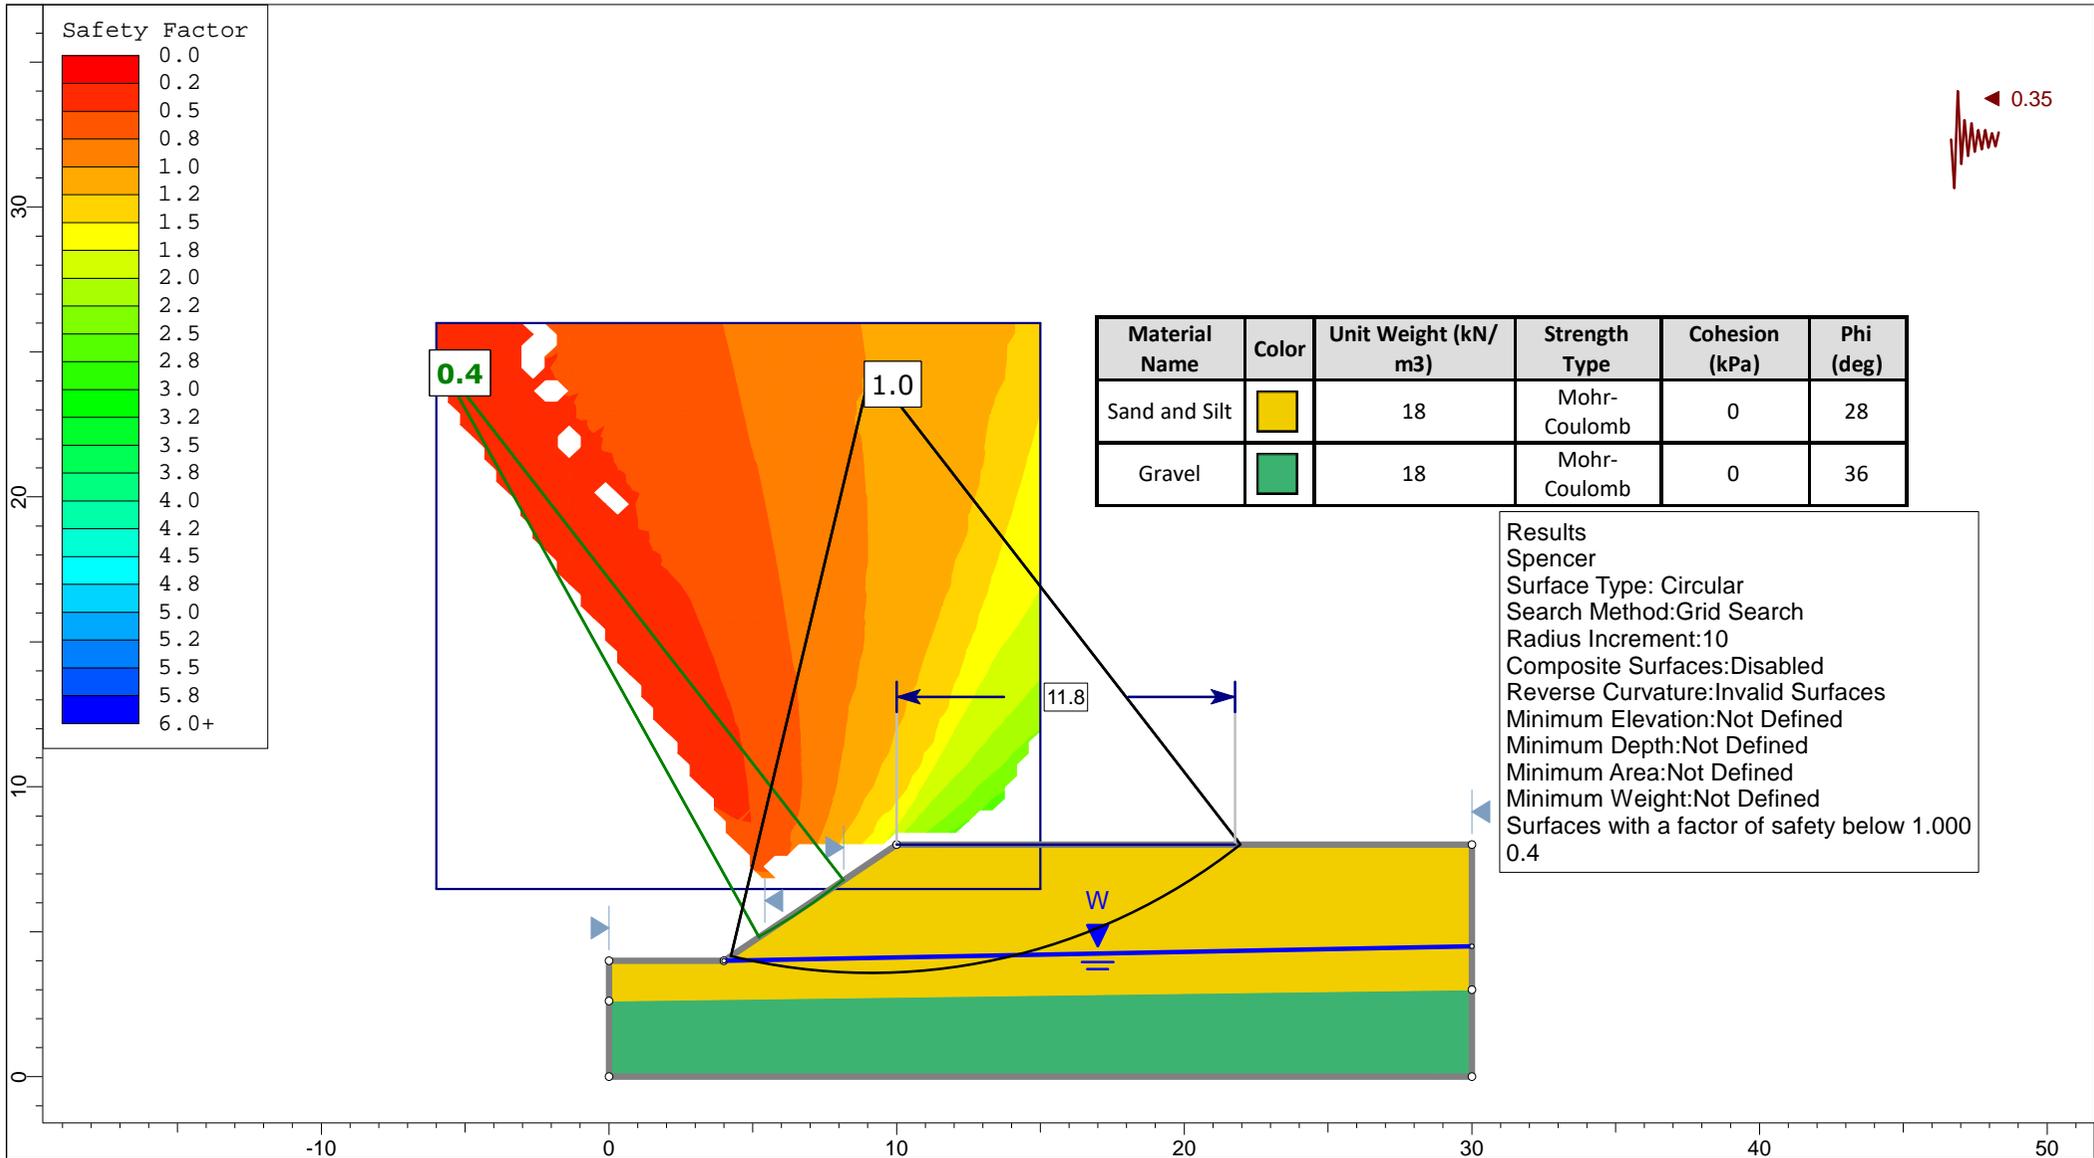
<p>Auckland   Christchurch 09 478 6655   03 343 5302 www.kga.co.nz</p>	Project		K210318 - 232 Styx Mill Road, Casebrook	
	Analysis Description		Seismic ULS - Circular - Measured Groundwater	
	Drawn By	TV	Company	KGA Geotechnical
	Date	27/05/2021	File Name	Seismic ULS.slmd

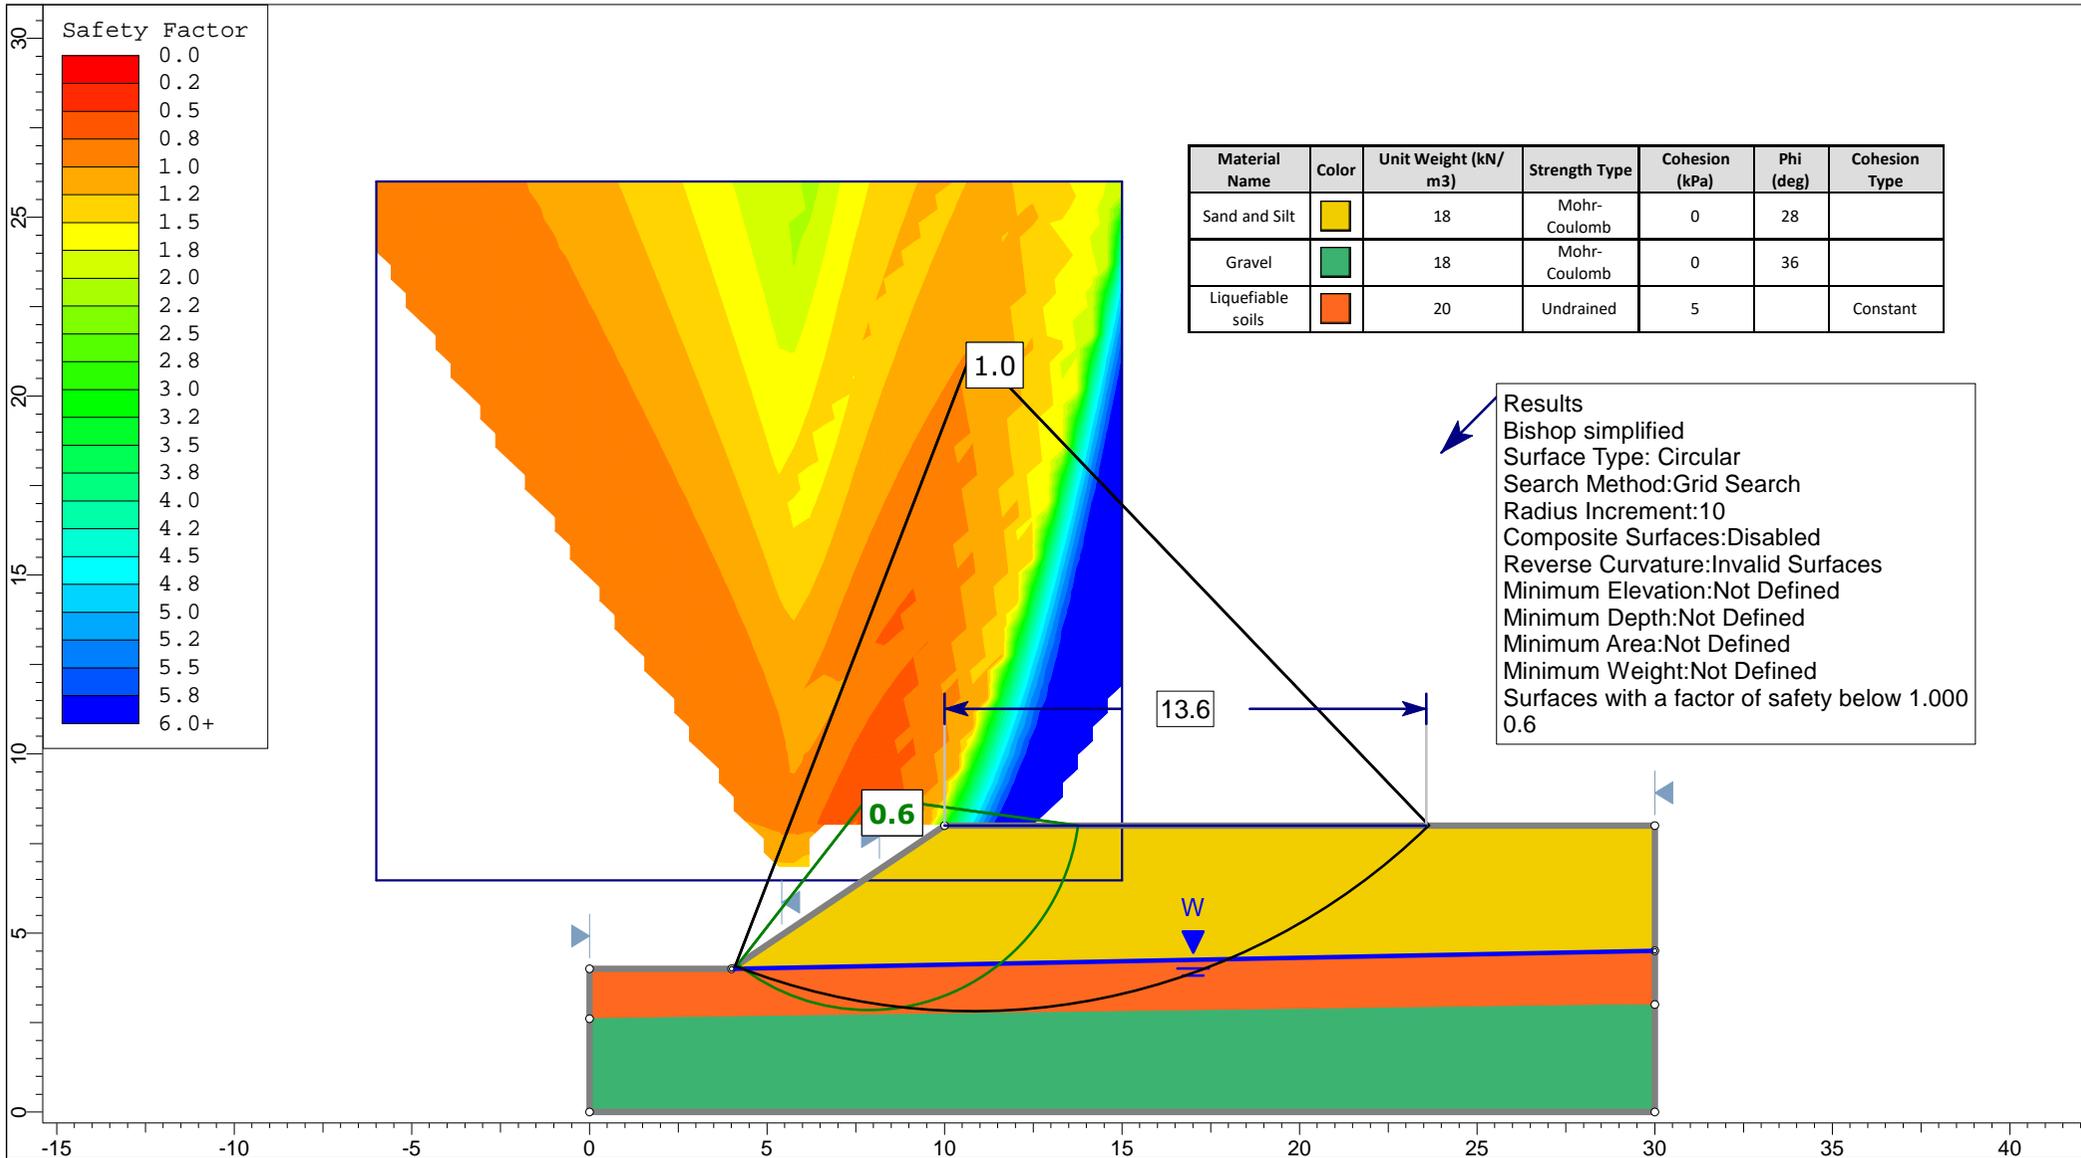
Material Name	Color	Unit Weight (kN/m <sup>3</sup> )	Strength Type	Cohesion (kPa)	Phi (deg)	Cohesion Type
Sand and Silt	Yellow	18	Mohr-Coulomb	0	28	
Gravel	Green	18	Mohr-Coulomb	0	36	
Liquefiable soils	Orange	20	Undrained	5		Constant
