# Land Information Memorandum

Property address:  
250 Styx Mill Road

LIM number: H00892132  
Page 1

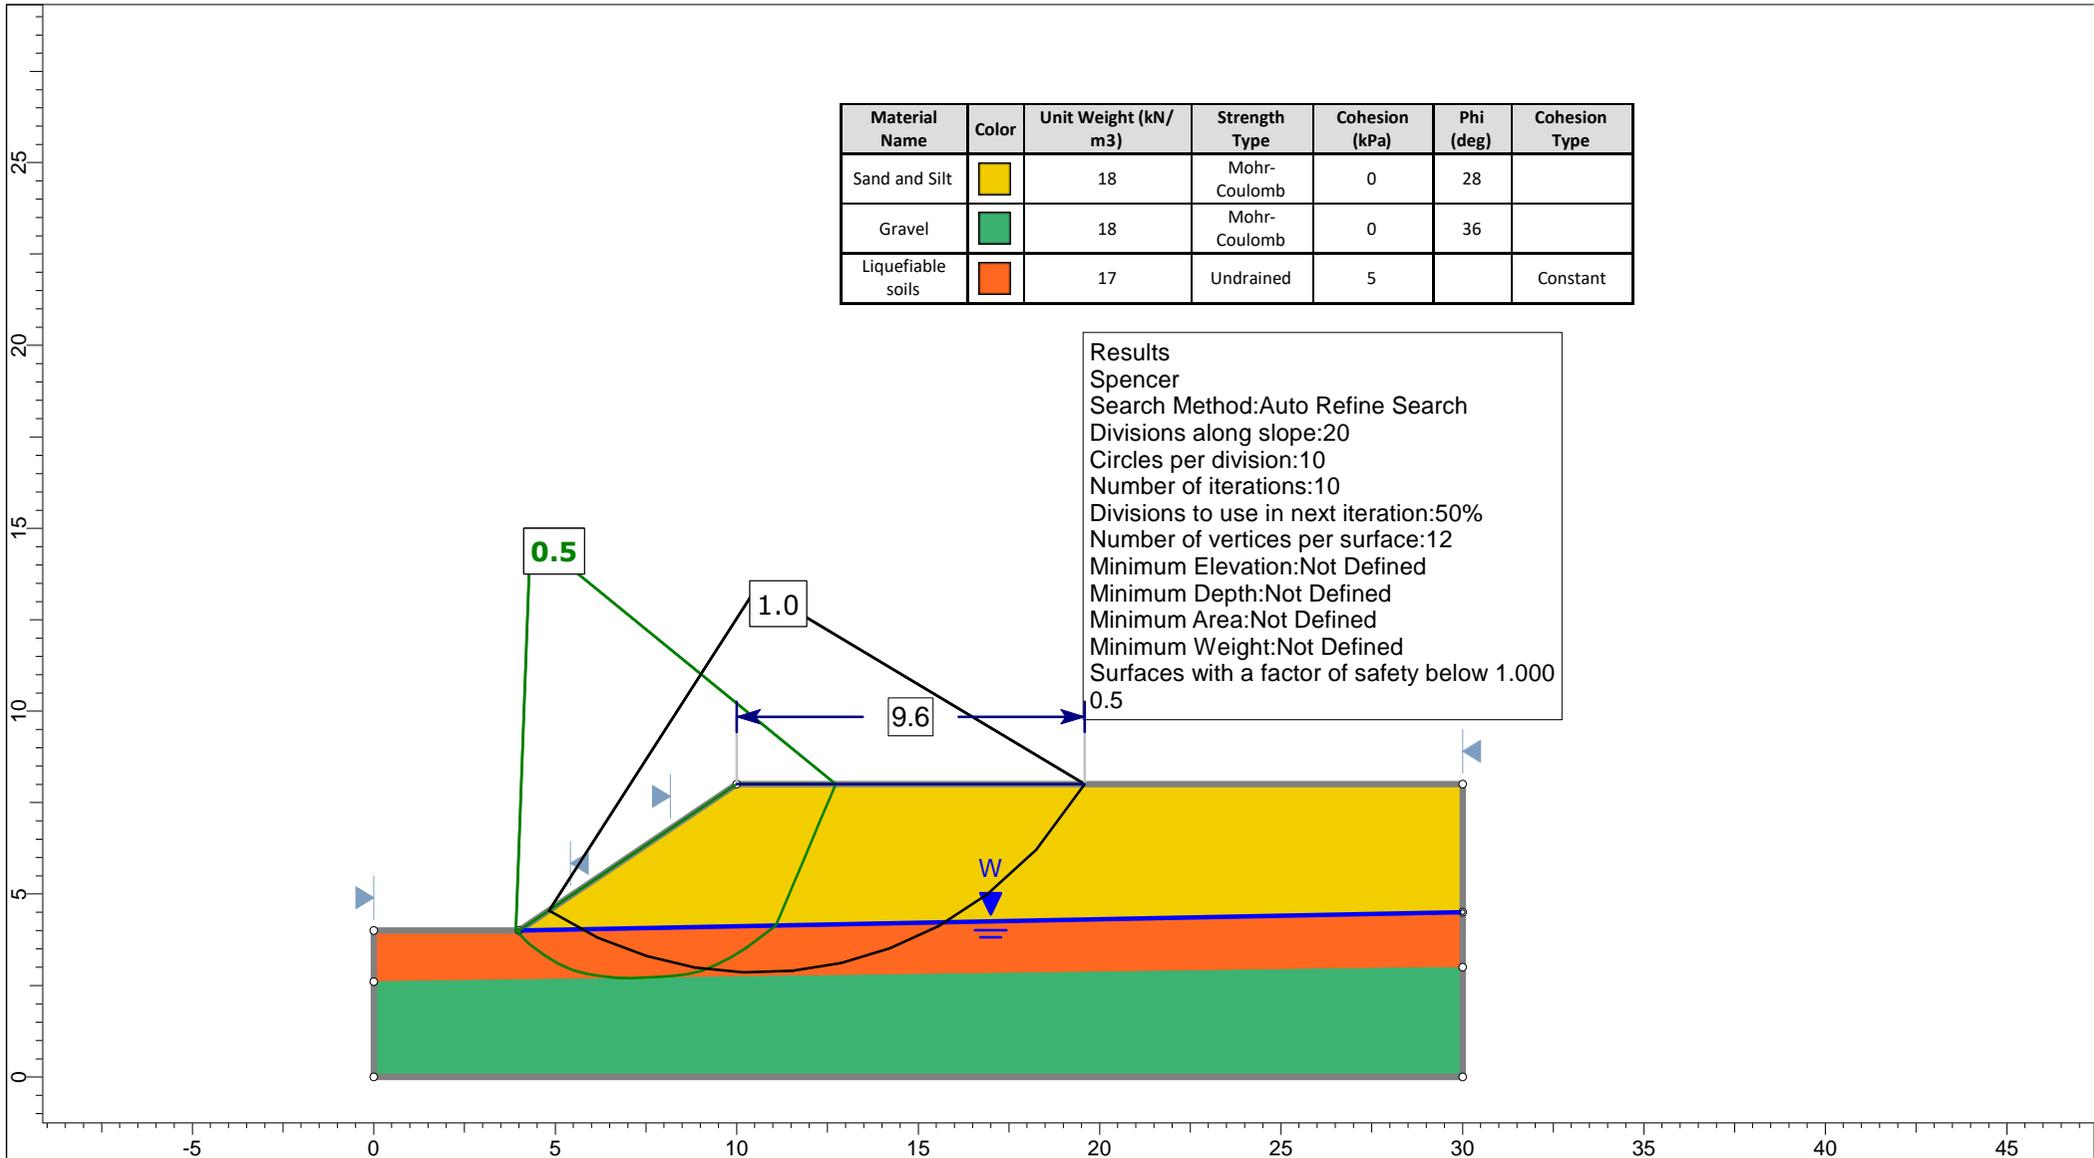
Material Name	Color	Unit Weight (kN/m <sup>3</sup> )	Strength Type	Cohesion (kPa)	Phi (deg)	Cohesion Type
Sand and Silt	Yellow	18	Mohr-Coulomb	0	28	
Gravel	Green	18	Mohr-Coulomb	0	36	
Liquefiable soils	Orange	17	Undrained	5		Constant
